Ground damage caused by the Noto Hanto Earthquake in 2007 (Mj=6.9), and its relation to the original landform

KOZABURO FUKUZUKA[1]; Yuji Kanaori[2]; Takahito Kuroki[3]

[1] yec; [2] Earth Sciences, Yamaguchi Univ; [3] Fukuoka Univ. of Education

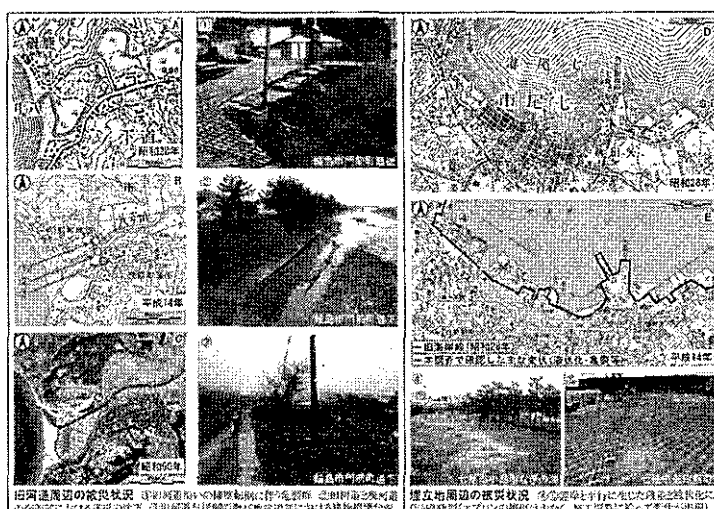
Low concrete wall of a levee revetment subsides at the intersection between old and new courses (Photograph No.2). Deformation of the wall is clearer in lower than upper side of the stream at the intersection, suggesting that water underflows from the new to the old river course. The deformation was probably generated by porosity increase of the ground due to the outflow of fine particles.

On the other hand, a settlement is located on a small highland along the left bank of the old course. Although the small highland may have been a natural levee, the boundary between the levee and the old river course is presently unclear. House damage is more remarkable at the margin of the small highland than inside it (Photograph No.3).

Large deformation sites in and around Port Nanao are plotted in the 2002 topographic map. The deformation is mainly caused by sand eruption due to liquefaction, ground stepping and surface cracks. Most damaging sites concentrate on relatively new reclamation land. Step-like cracks formed to be parallel to the direction of coastal revetment, and arrays of the sand eruption could be found along the crack. As shown in Photographs Nos 4 and 5, aprons of the revetment was less damaged, but the deformation appeared along the boundary between constructions of different ages. Among them, road surface surges in Naginoura region as shown in Photograph No.4. This surge suggests that the ground subsidence occurred before the Noto Hanto earthquake. In contrast, sites reclaimed before the World War II and earthquake-strengthening revetments are rarely damaged. Accordingly, it is point out that the generation of the ground damage by an earthquake is related to reclamation age, kinds of materials, and design manner of the reclamation site.

八ヶ川旧河道右岸の門前町鹿磯地区の木材加工工場では、旧河道沿いに施工された擁壁が転倒し、アスファルト舗装路盤に亀裂が生じている(写真)。亀裂が生じた路盤の基礎地盤は砂丘堆積物から構成されており、昭和28年発行の旧地形図では砂丘の分布が明瞭に確認される。ここでは工場の一部が倒壊するなど、深刻な建物被害が生じている。

旧河道と現河道が交差する箇所では、低水路護岸が沈下している(写真)。この交差部では上流側よりも下流側の交差部に顕著な変状が確認される。下流側において変状が顕著であることから、現河道から旧河道にかけて伏流水の流下があると推定され、変状の原因として細粒分の流出に伴う間隙率の増加が挙げられる。

一方、旧河道左岸の微高地には集落がある。この微高地は自然堤防であったと推定されるが、現況では旧河道との境界は不明瞭である。微高地縁部では、内側に比べて家屋の損壊が目立っている(写真)。

七尾港周辺において、主な変状が生じた箇所を平成14年刊行の地形図に示した。変状の多くは液状化に伴う噴砂と段差および亀裂である。また、被災箇所の多くは、昭和50年以降の比較的新しい埋立地に集中している。護岸にはそれに平行な階段状の亀裂が形成され、その亀裂に沿って液状化に伴う噴砂列が観察される。写真に示すように、噴砂列や段差が広範囲に分布しているものの、いずれの箇所においてもエプロン部の損傷は少なく、変状は主として施工境界に沿って出現している。特に、写真に示すなぎの浦地区では路盤が波打っており、能登半島地震以前から地盤沈下が生じていたことがわかる。これに対して、戦前の埋立地や耐震補強された岸壁では、被害がほとんど生じていない。これらのことから、埋立地における地盤災害は、埋め立て時期の新旧や埋め立て材料の種類および耐震を配慮した設計との関連性が指摘される。
