## Geo-Disaster Report

## Survey report on damage caused by 2019 Typhoon Hagibis in Marumori Town, Miyagi Prefecture, Japan

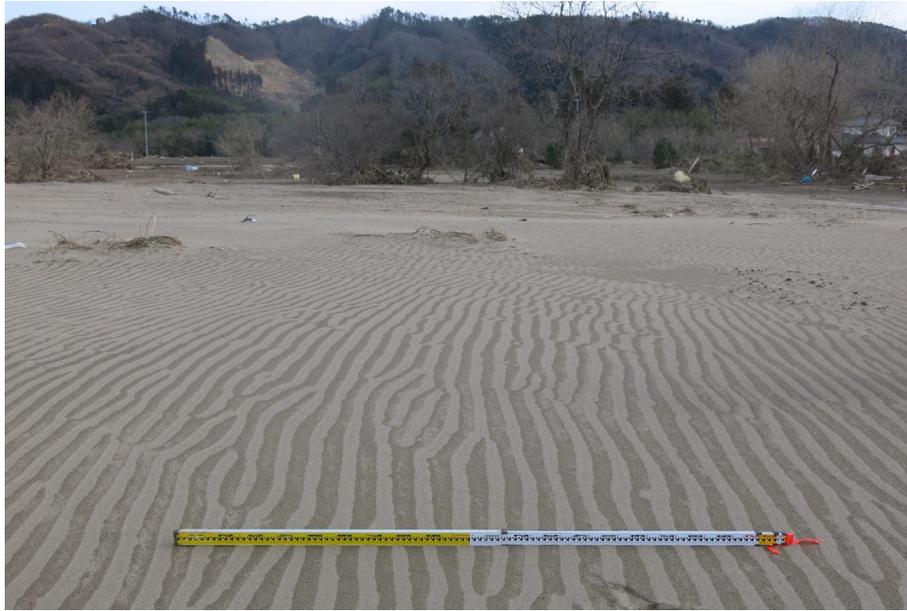
Fig. 8. Ripple marks observed at S3.

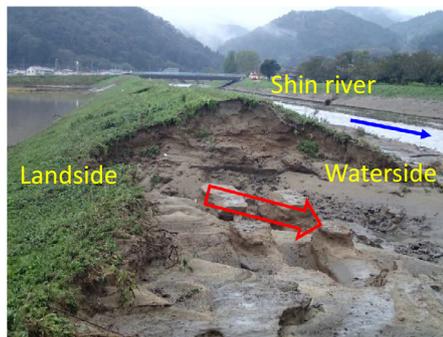
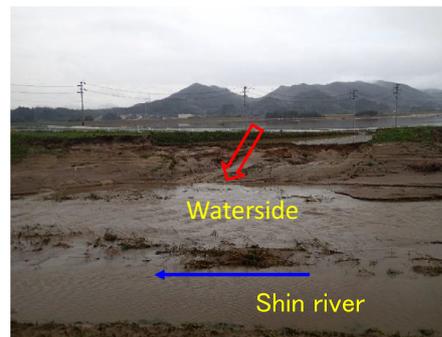
Fig. 9 shows a photograph of a levee breach that occurred on the right levee of the Shin River. The location of the levee breach is point A in Fig. 6. Photographs (a) and (b) in Fig. 9 were taken from the right and left levees,

respectively. As shown in the figure, it was concluded that the levee failure developed from the landside toward the waterside. Levee failures generally occur from the waterside toward the landside, but this failure occurred in the opposite direction. This unusual levee breach was caused by rising water levels on the landside. It has been suggested

that the river water flowed out from the levee breach points of the Shin and Gofukuya Rivers, increasing the water level in the area between the rivers. As the area is surrounded by rivers and a mountain, the inland water drains poorly. The water content of the soil here remained high even two months after the disaster.

(a) A photograph taken on the right levee

(b) A photograph taken on the left levee

Fig. 9. Levee breach occurring on right levee (Shin River).

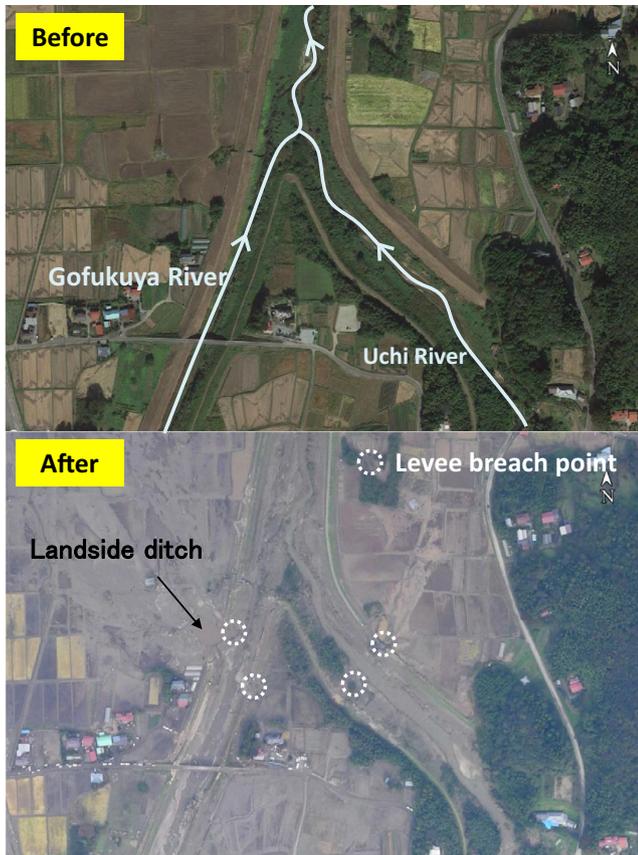
Fig. 10 displays aerial photos of the confluence of the Gofukuya and Uchi Rivers taken before and after the disaster. The aerial photos were obtained from Google Earth (Google). The location is shown as point B in Fig. 6. Levee breaches occurred at four points around the river confluence. The largest breach was observed on the left levee of the Gofukuya River. A large landslide ditch was also found near the levee breach (Fig. 11). Here, failure occurred in the normal direction, so this levee breach developed from the waterside to the landside. Our field survey team found driftwood remaining on top of other parts of the levee near the levee breach point. This indicates that overflow occurred around the levee breach point. In addition, although the team searched for traces of seepage failure in the levee, none were found around the levee breach point. It was therefore concluded that the levee breach had been induced by the erosion of the levee on the landside due to the overflow of river water.

Fig. 10. Aerial photos of levee breach points (Gofukuya River).

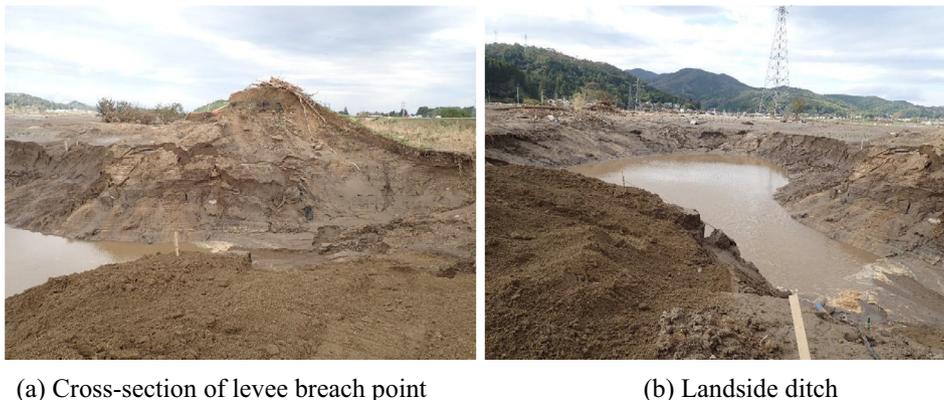
Fig. 11. Levee breach occurring on left levee (Gofukuya River).

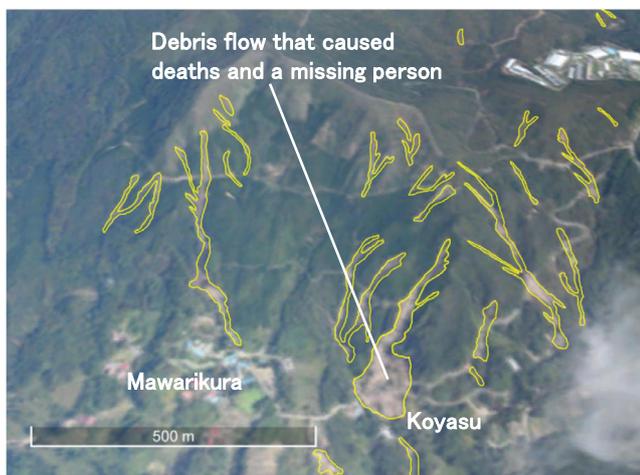
The locations of the Mawarikura and Koyasu communities are labeled at point A in Fig. 12. Fig. 13 presents aerial photos (downloaded from Google Earth) that were taken before and after the disaster. The flow paths of the debris flows occurring in this area are shown as yellow lines. One of the debris flows, shown in the photo given in Fig. 14, caused three deaths and one missing person (Fig. 13). A geologic map of this area is displayed in Fig. 15. This area consists of mostly mid-Cretaceous granitoids and granodiorites, with basalt in areas of higher ele-

Fig. 13. Aerial photograph with outlines of landslides in Mawarikura and Koyasu communities.

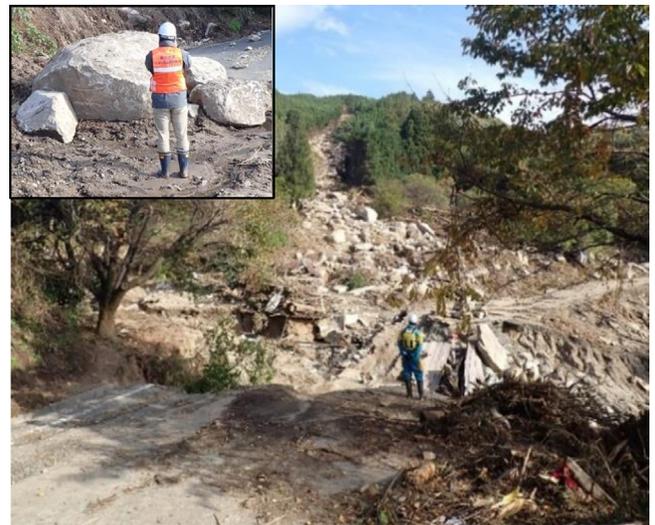
As shown in Fig. 14, many large boulders were deposited along the paths of the debris flows. The large boulders were detached from the granitoid and granodiorite bedrock. Although granitoids and granodiorite weather to granite soil, the subsurface parts usually do not weather because they are not exposed to air. As a result, large boulders remain on the slopes. In the debris flow described here, it is estimated that granite soil flowed as a result of heavy

rain and destabilized pieces of in situ bedrock, which were then picked up and carried along with the debris flow. The impact force of the debris flow was thus extremely large. The risks associated with debris flows, including large boulders, have also been pointed out in survey reports of recent disasters (e.g., Hashimoto et al., 2020).

Fig. 14. Photograph of debris flow occurring in Koyasu community.

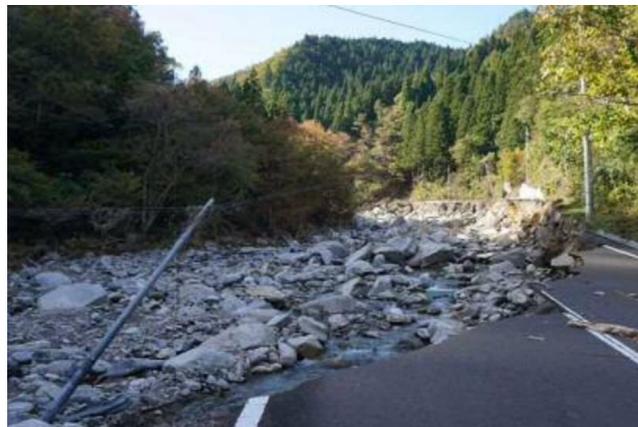
Fig. 18. Debris flow-induced road washout in middle reaches of Gofukuya River.

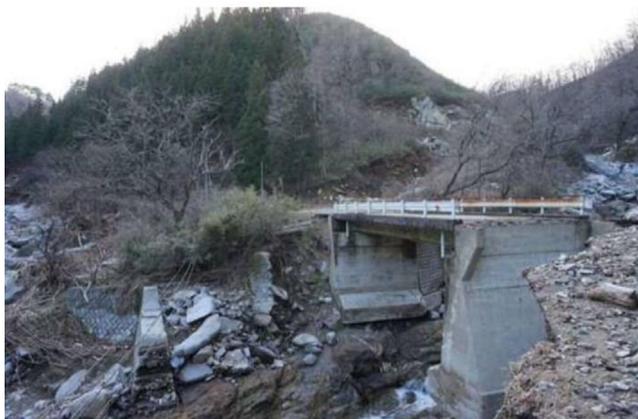
Fig. 17. Washout of backfill at bridge abutment in middle reaches of Gofukuya River.

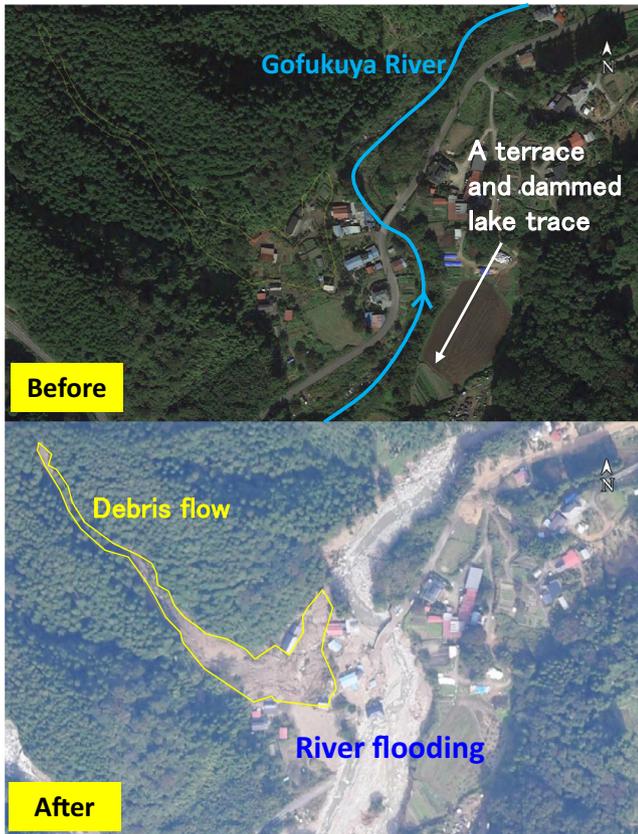
The Usudaira community is located in the middle reaches of the Gofukuya River, as shown by the dotted white line in Fig. 19. Fig. 20 shows aerial photos taken before and after the disaster. It can be seen from the figure that houses were destroyed by landslides and that the width of the river expanded greatly in the flood stage. Figs. 21 and 22 show damage to houses caused by landslides and river flooding. As landslides and flooding occurred at the same time, there was serious damage in the Usudaira community. Part of the debris flow path was previously designated as a sediment disaster hazard area, called a “yellow zone”, but in this event, a debris flow flowed beyond the designated zone. However, there were no casualties in this area, which is amazing considering the level of damage. One of the reasons for this result is that great efforts were made by the local residents to ensure strong mutual assistance. By sharing information among the residents and evacuating before the disaster, lives were protected in this area.

Fig. 20. Damage caused by debris flow and river flooding in Usudaira community.

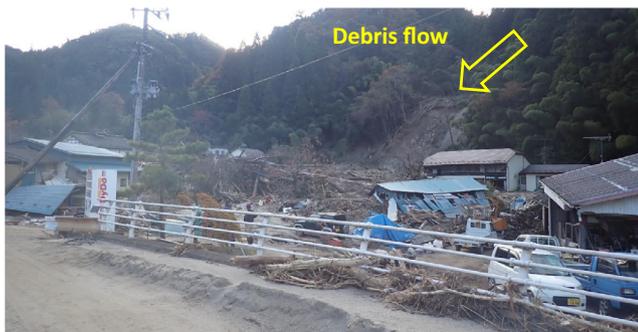
Fig. 21. Damage to houses caused by debris flow in Usudaira community.

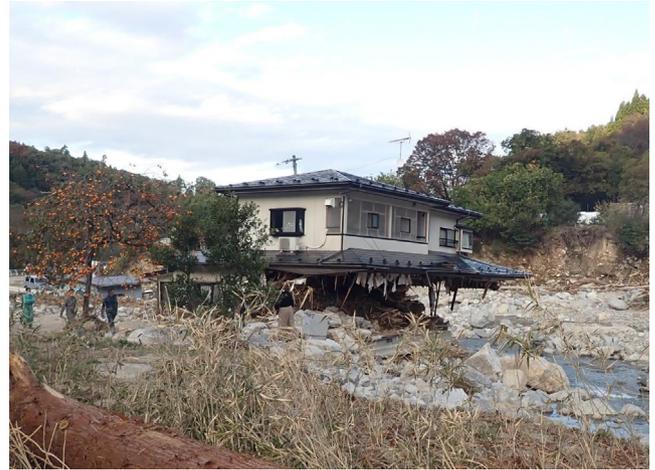
Fig. 22. Damage to house caused by river flooding in Usudaira community.

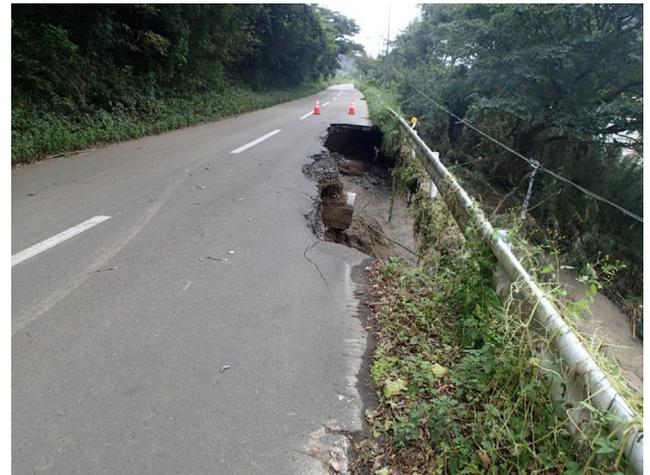
Fig. 23 shows an example of damage to Route 349. Erosion caused washouts to road shoulders and river banks. Although half of the road remained at this location, many road sections were completely washed out or were cut off by landslides.

Fig. 23. Failure of road shoulder on Route 349.

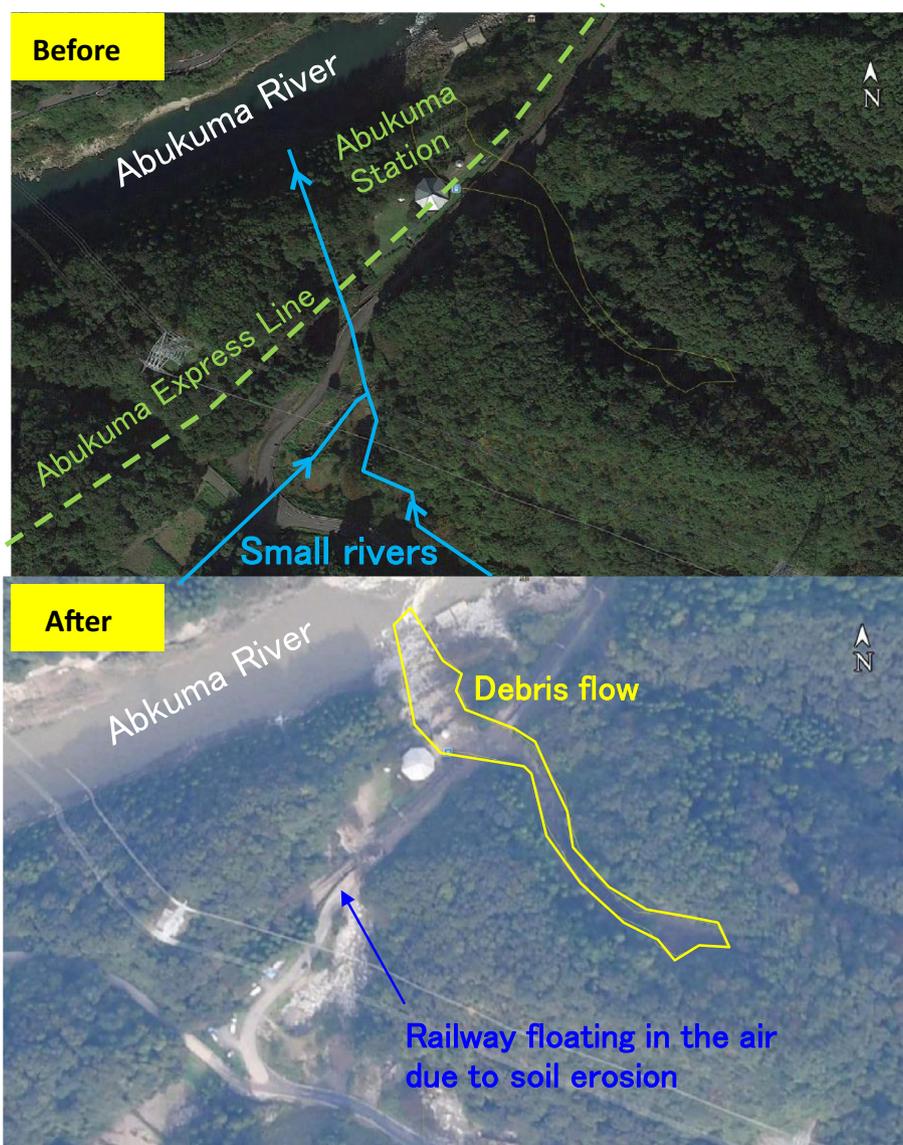
Fig. 24 displays aerial photos of Abukuma Station taken before and after the disaster. Debris flow and river flooding occurred at the same time near the station. The debris flow hit the platform of the station directly. In the same area,

Fig. 24. Aerial photographs of Marumori Station.

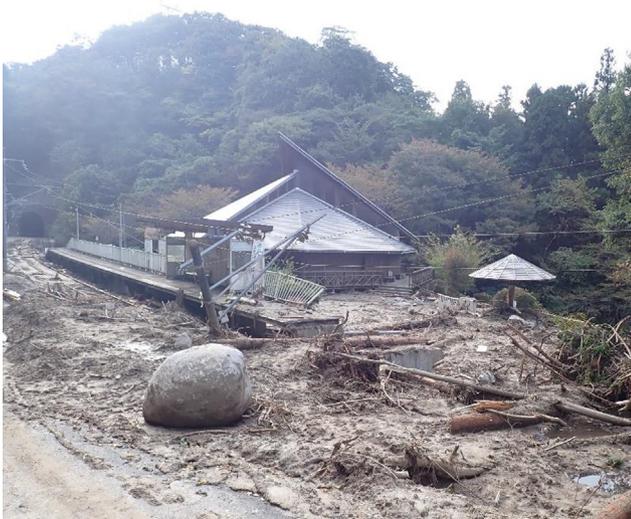
slightly farther from the platform, soil at the bottom of the railway track was washed out, and the track was floating in air. Figs. 25 and 26 show the damage caused by debris flows and river flooding, respectively. A small river flows perpendicular to both the road and the railway of the Abukuma Express Line. The two rivers merge just before an intersection, and then the river passes under the road and the railway through a box culvert. It can be estimated that the water volume increased sharply near the intersection with the influx of storm water and overflowed outside the box culvert, washing out the road and railway embankments.

Fig. 25. Damage caused by debris flow at Abukuma Station.

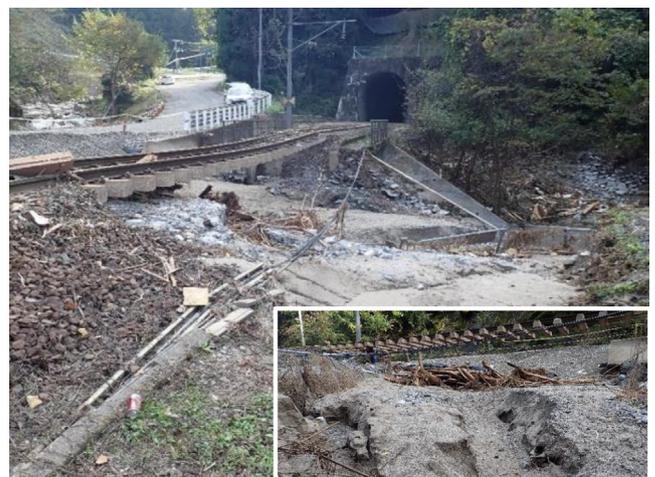
Fig. 26. Railway floating in air due to soil erosion.
