**Disaster Report**

# **The July 2020 Rainfall-Induced Sediment Disasters in Kumamoto Prefecture, Japan**

**Key words :** heavy rainfall, collapse, debris flow, sediment disaster, Kumamoto Prefecture

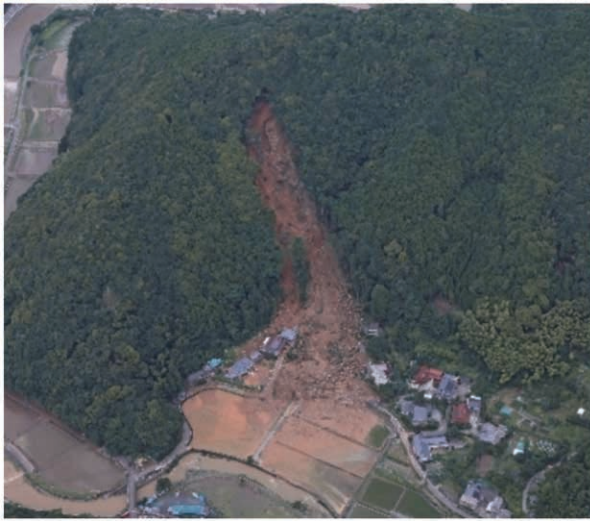
In Tagawa, Ashikita Town, a collapse occurred after 04:00 on July 4, killing three people (**Fig. 3**). According to rainfall data from near the disaster area (Ashikita observation station, Kumamoto Prefecture), 79 mm was recorded at 03:00-04:00 and 82 mm at 04:00-05:00 on July 4. Total rainfall from 04:00 on July 3, when the rainfall event began, to 05:00 on July 4, was 384 mm (**Fig. 4**).

**Fig.3** Panoramic view of the disaster area in Tagawa, Ashikita Town  
Courtesy of Asia Air Survey Co., Ltd., and Aero Asahi Corporation ; taken on July 4, 2020

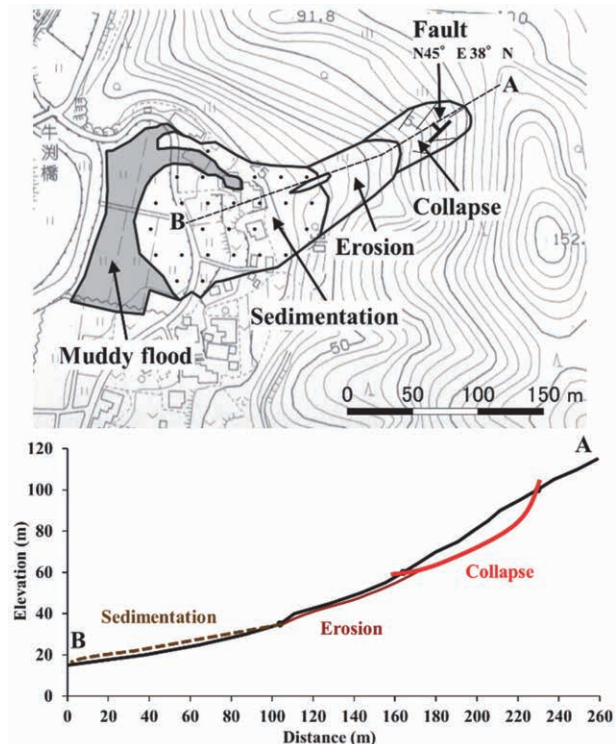
The collapse occurred at a slope angle of approximately  $30^\circ$  at an elevation of 60-100 m and collapsed sediment was deposited in a wide area at the foot of the slope with an angle of approximately  $10^\circ$  (**Fig. 5**). The slope length of the collapse and the

maximum width were approximately 80 m and 40 m, respectively. The maximum depth was approximately 10 m. The volume of the collapsed sediment was calculated to be 8,400 m<sup>3</sup> based on the length of 80 m, with an average width of 35 m and an average depth of 3 m of the collapse. If the volume of erosion in the area through which the sediment moved is included, it is estimated that approximately 10,000 m<sup>3</sup> of sediment was produced. A talus cone had developed at the foot of the collapsed slope, indicating that this is a place where sediment transport has repeatedly occurred.

**Fig.5** Plan and longitudinal section of the collapsed slope

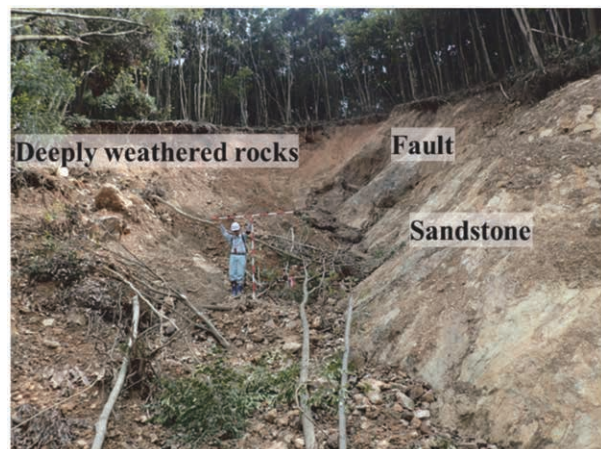
The head of the collapsed area has a V-shaped transverse form with a depth of 8 m. A fault is identified by sandstone outcropping on the right side toward the collapse (**Fig. 6**). On the fault surface, there is a thin clay layer and slickenside, and fracture zones consisting of angular gravel are distributed along the fault plane. The left side toward the collapse is the upper part of the fault plane, and the rocks are deeply weathered. The collapse is considered to have occurred

**Fig.6** Head of the collapse in Tagawa, Ashikita Town (photo taken on August 1, 2020)

due to the infiltration of large amounts of rainwater into the fractured and weathered strata.

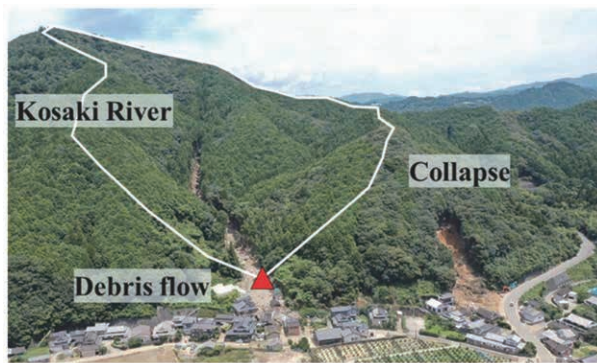
In Meshima, Ashikita Town, a collapse occurred after 05:00 on July 4, killing two people, and a debris flow occurred in the Kosaki River near the collapse site, damaging houses (**Fig. 7**). Rainfall conditions at the time of the disaster are shown in **Fig. 4**.

**Fig.7** Panoramic view of the disaster site in Meshima, Ashikita Town (photo taken on August 1, 2020)

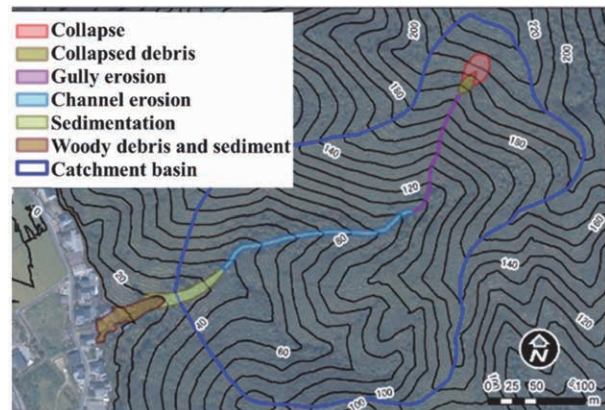
**Fig.9** Distribution of sediment transport in the Kosaki River

**Figure 9** shows the distribution of sediment transport in the Kosaki River (basin area:  $0.1 \text{ km}^2$ ). A 17-25 m wide, 30-40 m long, and 3-5 m deep collapse occurred at the head of the Kosaki River at an elevation of 200-220 m. Most of the collapsed sediment was deposited at the foot of the collapse site. Downstream, 2 m wide and 0.8-1.4 m deep gully erosion occurred in a 150-m-long zero-order valley with a  $30^\circ$  riverbed angle. Further downstream, 2-5 m wide and 1-2 m deep channel erosion occurred in a 230-m-long first-order channel with a  $15^\circ$  riverbed angle. The volume of this eroded sediment was estimated to be  $1,500 \text{ m}^3$ , which was discharged downstream with eroded trees. In the downstream

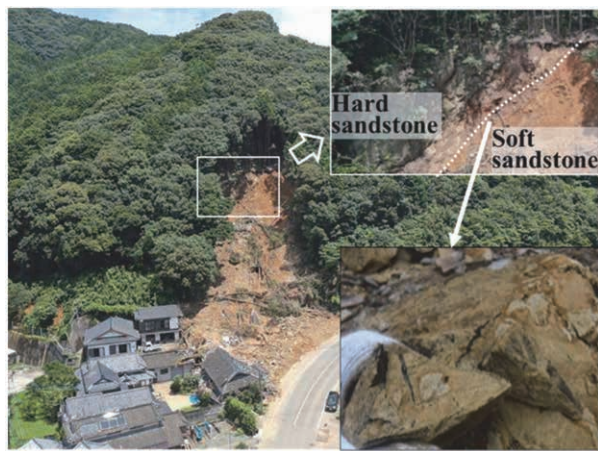
**Fig.8** Collapse and damage in Meshima, Ashikita Town (photo taken on August 1, 2020)

concave slope. A boundary between hard and soft bedrocks was observed in the head scarp (**Fig. 8**). Hard sandstone was distributed on the left side toward the collapse site, and deeply weathered sandstone was distributed on the right side. The collapse is considered to have been caused by an increase in pore water pressure due to rainwater infiltrating the soft sandstone, leading to the foot collapsing, followed by the collapse of the hard sandstone from above.

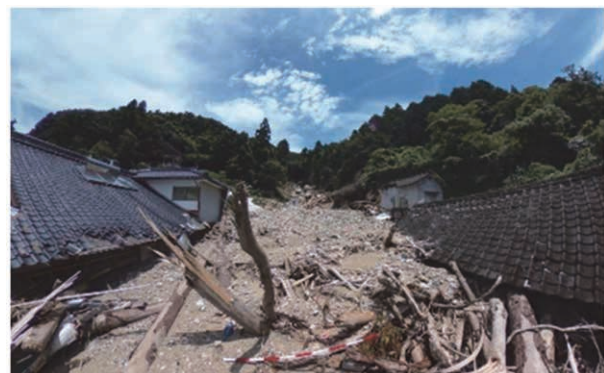
**Fig.10** Damage downstream of the Kosaki River (photo taken on August 1, 2020)

sedimentation area, approximately  $1,200 \text{ m}^3$  of sediment accumulated with a width of 5-10 m and thickness of 2 m. In addition, the remaining sediment and large woody debris caused damage to houses downstream (**Fig. 10**).

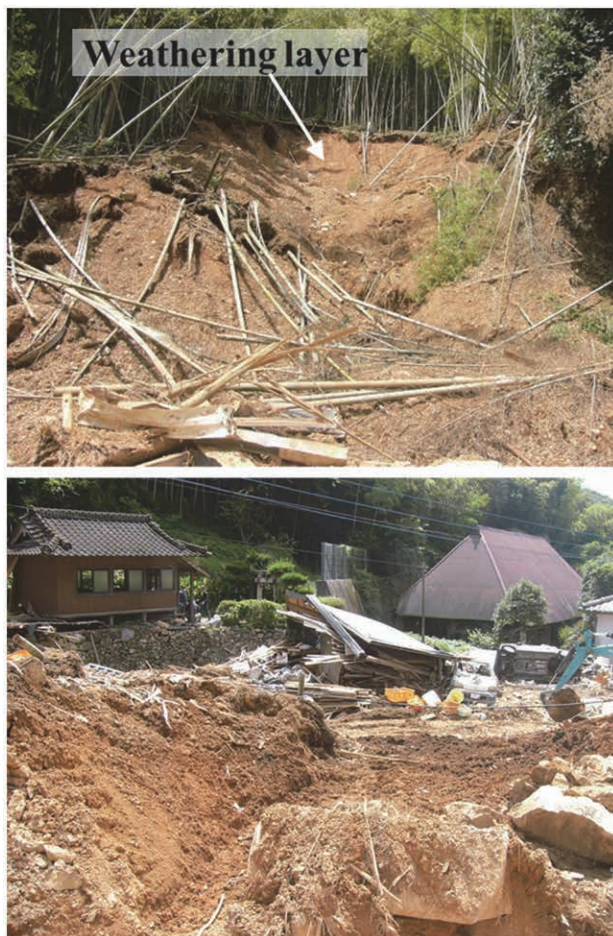
In Fushiki, Ashikita Town, a collapse occurred at approximately 05:00 on July 4, killing one person (**Fig. 11**). According to the rainfall data from near the disaster area (Tanoura observation station, Kumamoto Prefecture), 129 mm was recorded at 03:00-04:00 and 97 mm at 04:00-05:00 on July 4. There was cumulative rainfall of 492 mm from 04:00 on July 3, when the rainfall events began, to 05:00 on July 4 (**Fig. 12**).

The collapsed slope angle was  $36-38^\circ$  and convex or rectilinear in the longitudinal direction and ridge-shaped in the transverse direction. The geology was clay-slate, including hard chert and basalt rocks of several tens of centimeters to several meters in size. It was strongly weathered with reddening from the surface to a depth of approximately 5 m. The collapsed length was 56 m, with a maximum width of 20 m, maximum depth of 5 m, and a volume of sediment of

**Fig.11** Collapse (upper) and damage (lower) in Fushiki, Ashikita Town (photos taken on August 1, 2020)

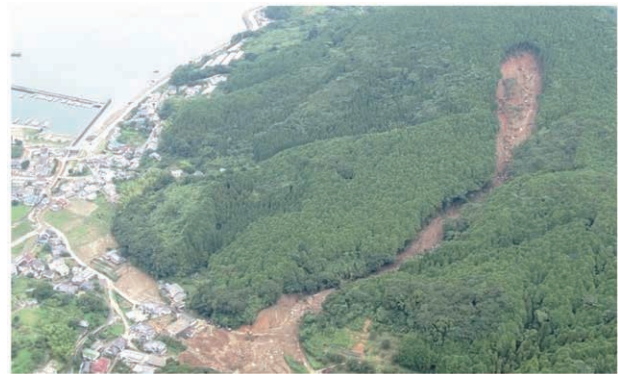
A debris flow occurred at 5 : 40 on July 4 at Otsubo River 1 in Fukuhama, Tsunagi Town, killing three people (**Fig. 13**). **Figure 14** is a topographic map and

**Fig.13** Disaster area in Fukuhama, Tsunagi Town (photo taken on July 13, 2020, courtesy of Kyushu Regional Development Bureau, Ministry of Land, Infrastructure, and Transport)

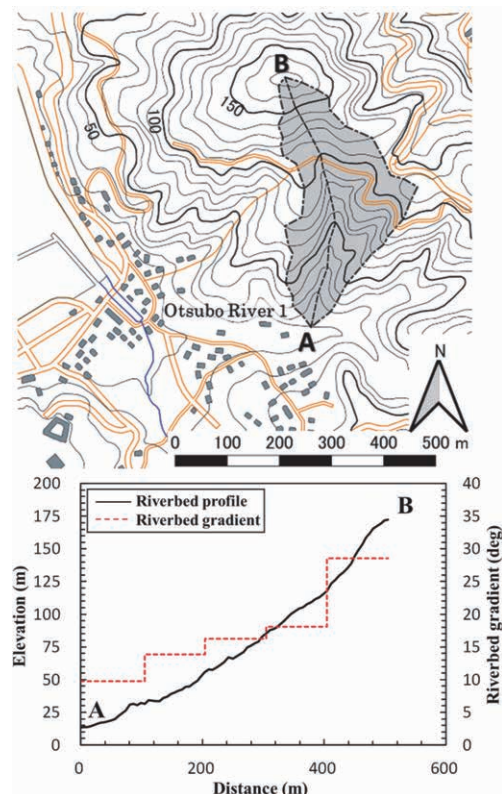
**Fig.14** Topographic map and longitudinal section of Otsubo River 1

longitudinal section of Otsubo River 1 (basin area 0.068 km<sup>2</sup>). The slope of the riverbed was approximately 10° at point A and became steeper upstream, reaching 28° at point B.

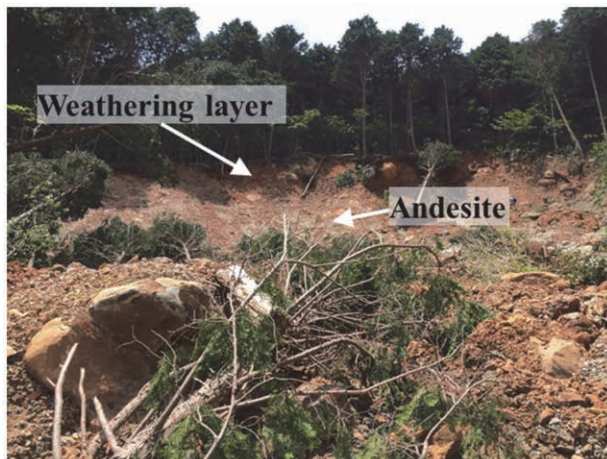
Fig.16 Head of the collapse in Otsubo River 1 basin (photo taken on August 1, 2020)

Figure 16 shows the head scarp and sliding surface of the collapse. The collapse depth was 3-4 m, and the width was 40 m. The slope of the sliding surface was approximately  $45^\circ$ , and the slope of the surface of the collapsed sediment remaining in the collapse area was  $35^\circ$ . The collapsed slope consisted of Hisatsu volcanic

andesite and subordinate siltstone.

Water came out from the boundary between them. A white clay layer was observed at the stratum boundary, indicating the possibility of a fault plane. In addition, mixed rocks consisting of mudstone and sandstone were distributed in the lower part of the collapsed slope, and gravels such as chert and limestone were also observed.

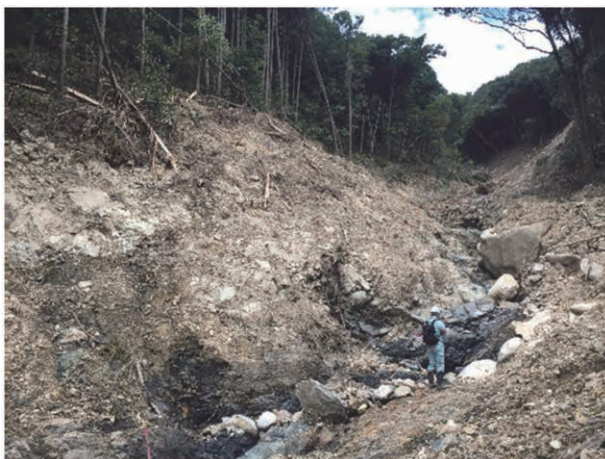
Fig.17 Erosion by debris flow in Otsubo River 1 (photo taken on August 1, 2020)

The collapsed sediment became a debris flow and flowed downstream while eroding the stream bank and bed (Fig. 17).

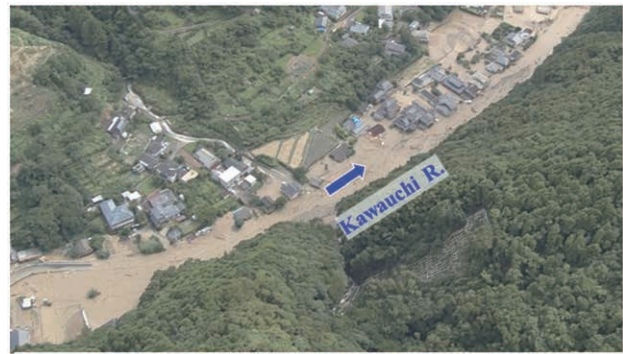
Fig.18 Sediment and flood damage in the Kawauchi River basin (photo taken on July 4, 2020, courtesy of Kyushu Regional Development Bureau, Ministry of Land, Infrastructure, and Transport)

A sediment and flood damage occurred in the downstream area in the Kawauchi River (Fig. 18). The residents evacuated beforehand and there were no human casualties; however, many houses were destroyed, and sediment was deposited on floors. According to rainfall data from the Kounose rainfall station installed by the Ministry of Land, Infrastructure, Transport, and Tourism, MLIT, a maximum hourly rainfall of 78 mm and cumulative rainfall of 564 mm were recorded on July 3-4 (Fig. 19).

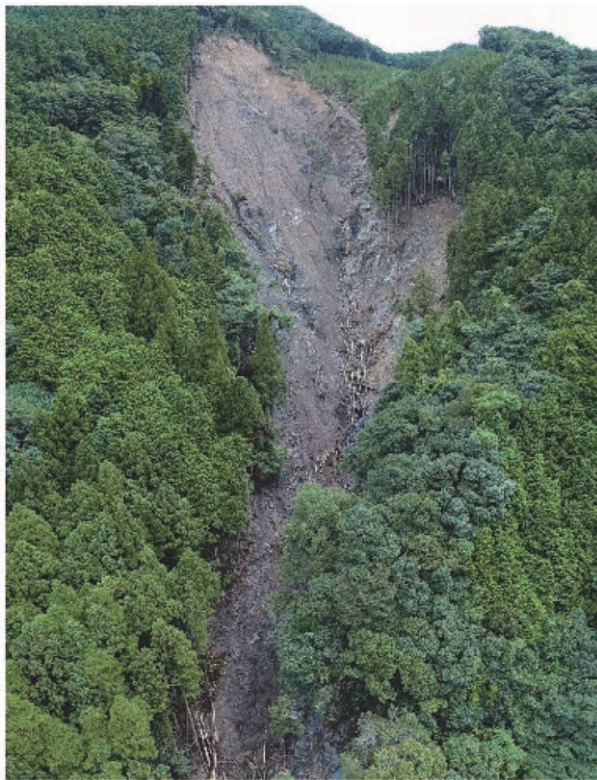
**Fig.21** Collapse of a right bank stream upstream of the Oiwa area of the Kawauchi River (photo taken on August 11, 2020)

and bank erosion, and debris flows, and a large amount of sediment was produced. In the right bank stream upstream of the Oiwa area, five collapses occurred on a steep slope of more than 40°, one of which was due to a fractured weathering layer (**Fig. 21**). The total volume of collapsed sediment was estimated to be approximately 20,000 m<sup>3</sup>, and the sediment flowed downstream into the Kawauchi River while eroding the stream bank and bed. As the sediment flowed through a narrow channel 6 m wide, it is assumed that the five collapses did not co-occur. The resulting sediment flowed down from each collapse separately. In addition, approximately 13,000 m<sup>3</sup> of sediment was estimated to discharge into the Kawauchi River due to the collapse from the crushed weathering layer and the accompanying debris flow in the stream on the left bank of the Matsuno area (**Fig. 22**).

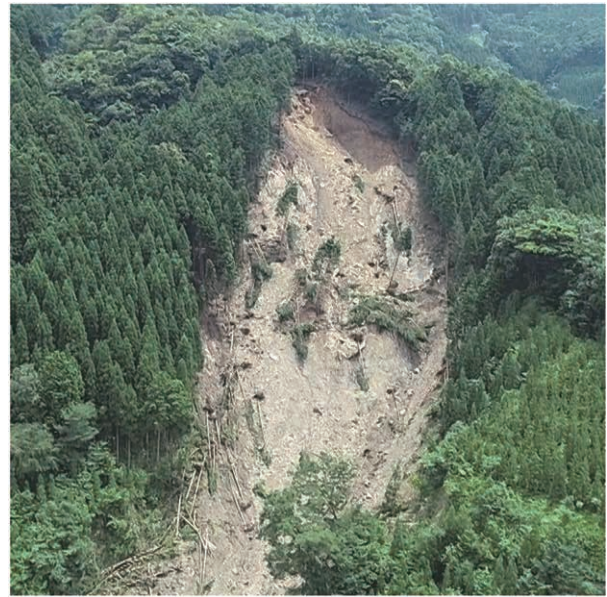
**Fig.22** Collapse of a left bank stream in the Matsuno area of the Kawauchi River (photo taken on July 18, 2020, courtesy of Kyushu Regional Development Bureau, Ministry of Land, Infrastructure, and Transport)

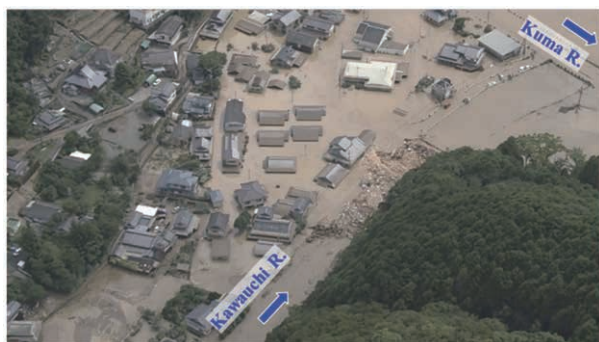
Sediment and flood damage occurred mainly at about 1.0 km between Kounose and Matsuno districts and about 0.5 km between Hiata and Oiwa districts. The main cause of sediment and flood damage may have been that sediment and floodwaters were not easily discharged into the Kuma River due to the backwater effect and were deposited in large quantities in the section of the Kawauchi River mentioned above (**Fig. 23**).

**Fig.23** Flood retention in the Kawauchi River due to backwater effect from the Kuma River (photo taken on July 4, 2020, courtesy of Kyushu Regional Development Bureau, Ministry of Land, Infrastructure, and Transport)
