Disaster Report**Sediment-related Disasters in Petrópolis, Brazil, on February 15 and March 20, 2022***Hidetoshi OCHI¹, Yoshifumi SHIMODA², Yosuke NISHIO² and Rafael Pereira MACHADO³¹ Sabo Planning Division, Sabo Department, Ministry of Land, Infrastructure, Transport and Tourism (2-1-3 Kasumigaseki, Chiyoda-ku, Tokyo 100-8918, Japan) & JICA Expert

The municipality of Petrópolis was hit by heavy rains on February 15 and March 20, 2022 resulting sediment-related disasters. The disaster on February 15, 2022 was caused by heavy rain 253 mm which fell in 3 hours, resulting in 238 fatalities. The disaster on March 20, 2022 was caused by 548 mm/24hr of rainfall which lasted longer than that of February 15, 2022, resulting in seven fatalities. These heavy rains triggered more than 370 landslides, making it the worst disaster ever recorded in the municipality. This report provides an overview of the disaster and the characteristics of four of these more than 370 landslides as examples.

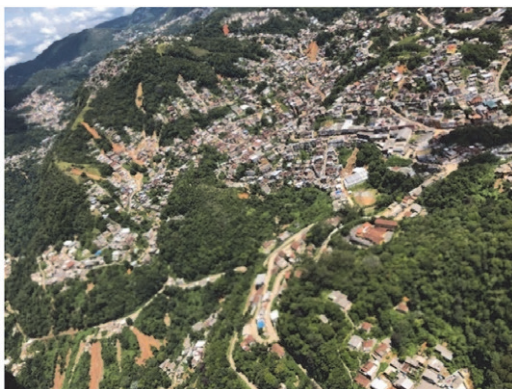
mountains by weathering and erosion, and rocky outcrops, with few flat areas (**Fig. 3**). In Petrópolis District where the series of disasters occurred, there are many hills and mountains with specific heights ranging from 50 to 200 meters above the valley floor. The landslides occurred on the slopes of these hills, rocky outcrops and mountains, striking residential areas on the slopes and lower part of slopes (**Fig. 4** and **Fig. 5**). Most of the landslides were shallow landslide with a narrow width relative to their length, originating around the knick point near the top of the slope. In the case of **Fig. 5**, shallow landslide occurred on the weathered surface layer of a granite outcrop at the top of the hill. From the air observation, most of the landslides were shallow landslide on the slopes, and there were very few cases that could be considered as debris flow.

Fig.4 Landslides on a hill in the southern part of Petrópolis District.

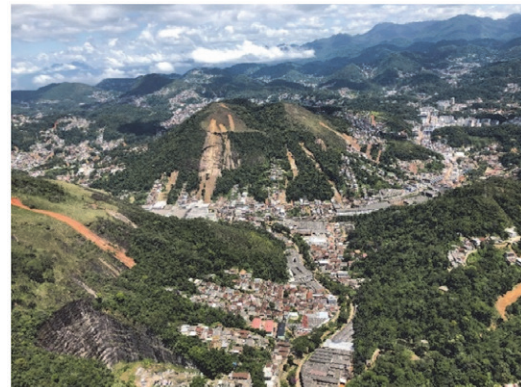
Fig.5 Landslides on a hill with rocky outcrops in the eastern part of Petrópolis District.

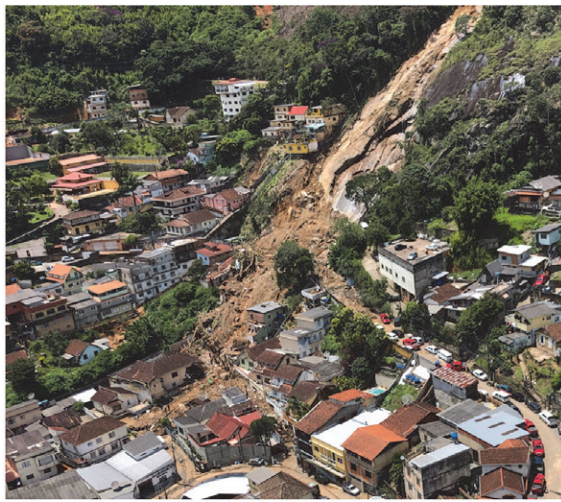
Fig.11 View of the landslide Site A in Caxambu Neighborhood from the air.

The landslide Site A shown in **Fig. 11** occurred on the north slope located at coordinates lat $22^{\circ}30'26.90''$ S, long $43^{\circ}9'31.08''$ W. in Caxambu Neighborhood. The average gradient of the collapsed slope was approximately 30 degrees as read from the contour lines, and the length, average width and area of the collapsed slope were approximately 60 m, 20 m and $1,000 \text{ m}^2$ respectively, according to the satellite image. The length, average width and area of the deposited debris were approximately 140 m, 30 m and $4,400 \text{ m}^2$ respectively (**Fig. 12**). Visual inspection of both sides of the collapse site revealed that cracks parallel to the slope had developed in the granitic bedrock (**Fig. 11** and **Fig. 13**). The bedrock was covered with less than 1 m of weathered residual soil with vegetation including tall trees. The diameter of the collapsed rock was 2 to 3 meters.

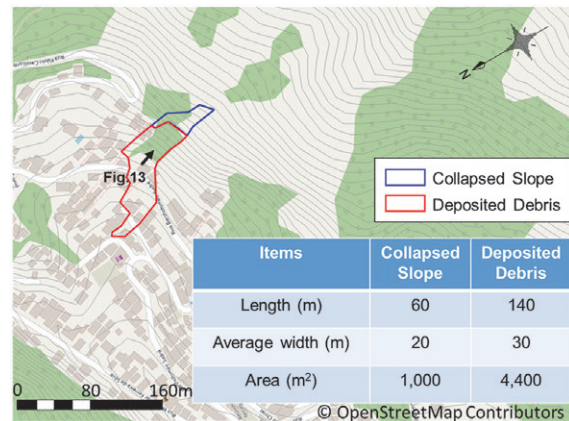
Fig.12 Topography and information of the landslide at Site A in Caxambu Neighborhood. The green hatching in the figure represents forest covers. This definition on the green hatching is the same in Figs. 14, 19 and 21.

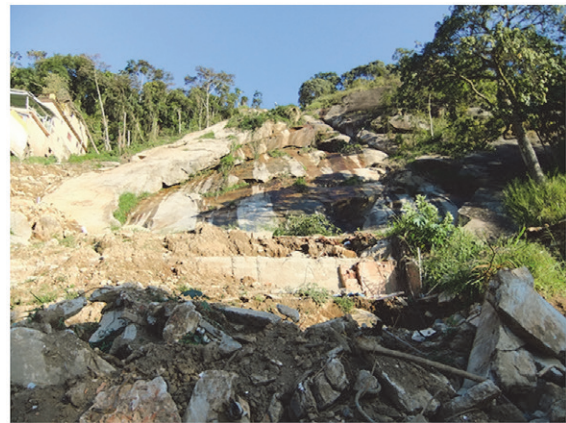
Fig.13 Situation of the landslide at Site A in Caxambu Neighborhood.

vegetation on the collapsed slope was similar to that of the adjacent land, the collapse was probably caused by groundwater from short-term heavy rainfall. The official also said that the slope may have been saturated, because a person who lived in the affected house posted a video taken at the time of the disaster on a social networking site showing a large amount of water flowing indoors.

Even though the collapsed layer thickness of weathered residual soil was less than one meter, about 10 houses were destroyed at the foot of the slope where debris had deposited. The collapsed slope was long and constant, and its base rock had cracks parallel to the slope, which allowed the collapsed material to reach the foot of the slope without slowing it down. This may have been the cause of the significant damage.

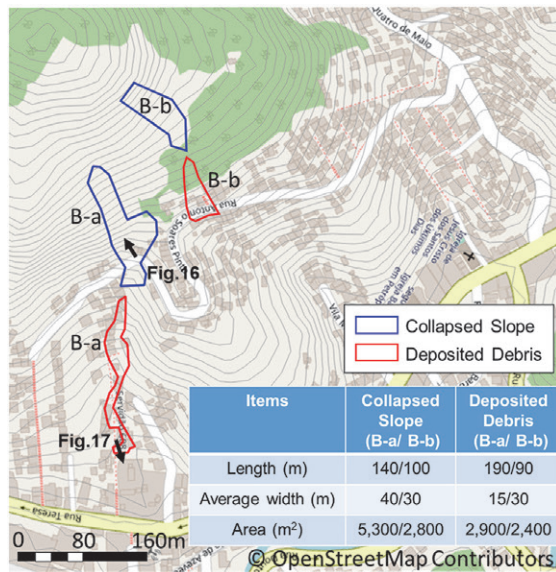
Fig.14 Topography and information of the landslide at Site B in Vinte e Quatro de Maio Neighborhood.

east from 24 de Maio Street into Antônio Soares Pinto Street with coordinates lat 22° 31' 6.51" S. long 43° 10' 23.99" W. in Vinte e Quatro de Maio Neighborhood (**Fig. 14** and **Fig. 15**). This landslide is called "608 landslide" based on the number of the address of the nearby shopping center which is 608 Teresa Street. The average gradient of the collapsed slope was approximately 30 degrees as read from the contour lines, and the length, average width and area of the collapsed slope were approximately 140 m, 40 m and

5,300 m² respectively, according to the satellite image. The length, average width and area of the deposited debris were approximately 190 m, 15 m and 2,900 m² respectively (**Fig. 14**). The slope where the landslide occurred was a granite outcrop, the surface of which was partially covered by weathered residual soil less than 1 m thick with a dense herbaceous and shrub cover. The slope had two rows of approximately 20-meter-long rockfall prevention nets and a 45-meter-long drainage ditch parallel to the contour line to gather surface water from the slope and direct it into a vertical drain. However, the rockfall prevention nets could not fully capture the falling rocks, and the drainage ditch was partially destroyed by the falling rocks (**Fig. 16**). The collapsed rocks flowed over Antônio Soares Pinto Street in the middle of the slope, destroying houses in the lower part of the slope, and stopped at the wall of a shopping center facing Teresa Street (**Fig. 17**).

Landslide B-b also occurred on the west side of landslide B-a on February 15, 2022 (**Fig. 14**). At that time, the collapsed rocks did not reach the residential

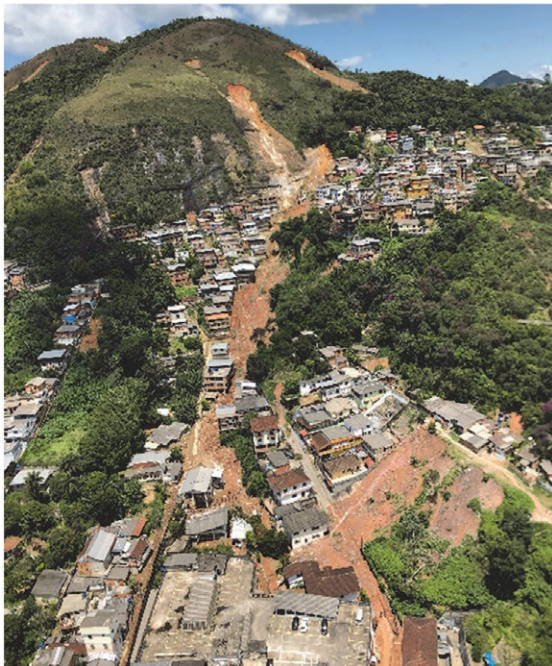
Fig.15 View of the landslide Site B in Vinte e Quatro de Maio Neighborhood from the air.

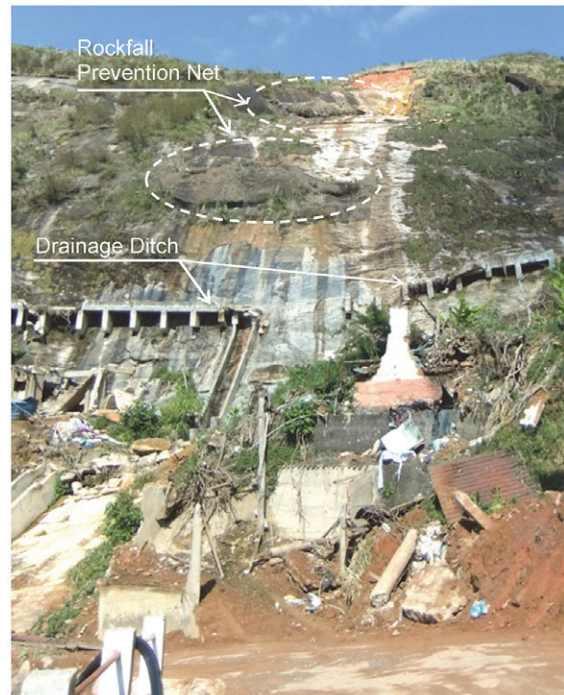
According to the municipality government official, there was almost no vegetation near the rockfall prevention nets before the disaster. The reason why the falling rocks were not fully caught by the nets and reached the foot of the slope was because there were more rocks than expected that collapsed and also landslides occurred on the slope outside of the netting area.

Fig.16 Situation of the collapsed slope at Site B-a in Vinte e Quatro de Maio Neighborhood.

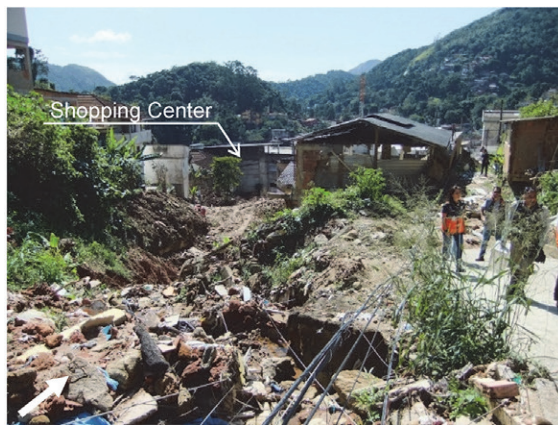
Fig.17 Situation of debris B-a stopped at the wall of a shopping center facing Teresa Street.

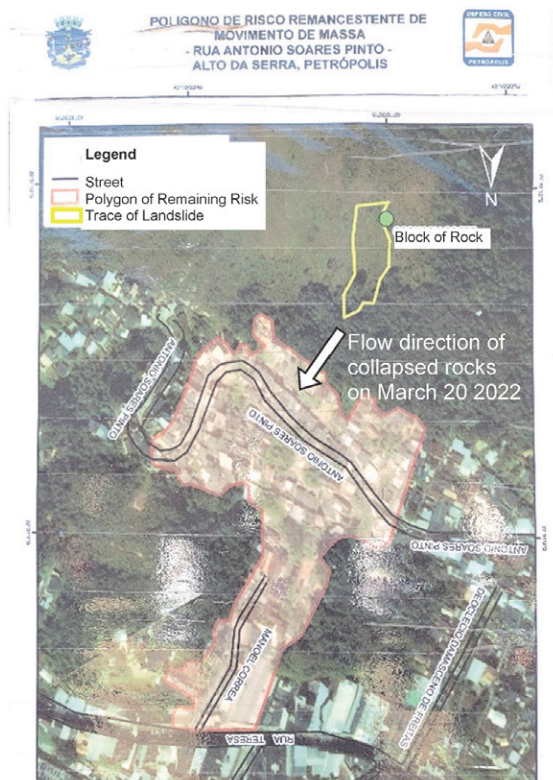
According to the municipality government official, after the landslide occurred on February 15 2022, a field survey revealed that there was a risk of the landslide spreading. Therefore, they designated the area included within a 30-degree range on either side downward from the landslide as a remaining mass movement risk area (**Fig. 18**), and ordered residents to

Fig.18 Remaining mass movement risk polygon, Antonio Soares Pinto Street, Alto da Serra, Petrópolis. Flow direction of collapsed rocks on March 20 2022 was added to the map of Petrópolis Civil Defense.

evacuate. As a result, although houses were damaged by the expansion of the landslide on March 20 2022, human casualties were avoided.

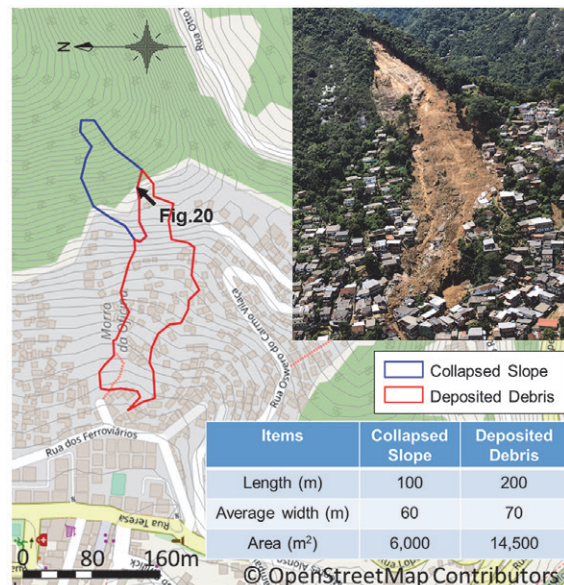
The landslide Site C occurred on February 15, 2022 is located on the west slope adjacent to Ferroviários Street with coordinates lat $22^{\circ}31'50.17''\text{S}$. long $43^{\circ}10'9.35''\text{W}$. in Alto da Serra Neighborhood. The average gradient of the collapsed slope was approximately 35 degrees as read from the contour lines, and the length, average width and area of the collapsed slope were approximately 100 m, 60 m and $6,000 \text{ m}^2$ respectively, according to the satellite image. The length, average width and area of the deposited debris were approximately 200 m, 70 m and $14,500 \text{ m}^2$ respectively (**Fig. 19**).

Fig.19 Topography and information of the landslide at Site C in Alto da Serra Neighborhood.

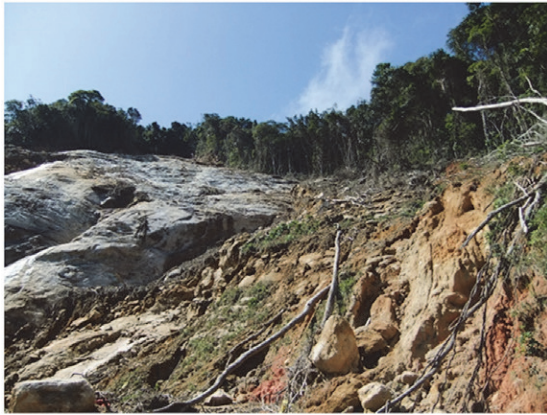
The base rock is granite and is generally poorly weathered, but some areas were discolored due to weathering. As in Site A, the base rock also has overhangs that may be remnants of avulsion and landslide. The base rock was covered with soil less than 1 m thick, where vegetation was dominated by tall trees (**Fig. 20**). A house once existed on a talus deposits in the middle of the slope, but the landslide washed its foundation and everything else away. Today, only gate of the house and a part of concrete pavement remain. According to the municipality government official, the sediment which collapsed in the upper part of the slope swept away the talus deposit as well, resulting in an increase in the amount of sediment which flowed down the lower part of the slope. As a result, many houses were destroyed on the lower part of the slope. Although some residents were able to

Fig.20 Situation of the landslide at Site C in Alto da Serra Neighborhood.

evacuate based on the early warning information issued by the municipality government, this site suffered the most human casualties in the disaster. Possible reasons for this include the relatively wide landslide width, the long debris depositional range due to the steep slope, the large amount of sediment transported by the erosion of talus deposit on the middle of the slope, and the development of residential land up to the slope. The reasons why many people did not evacuate despite the city issued the early warning information may include the possibility that the early warning information was not sufficiently communicated and that many people were under the impression that even if a landslide occurred, the sediment would not reach their houses.

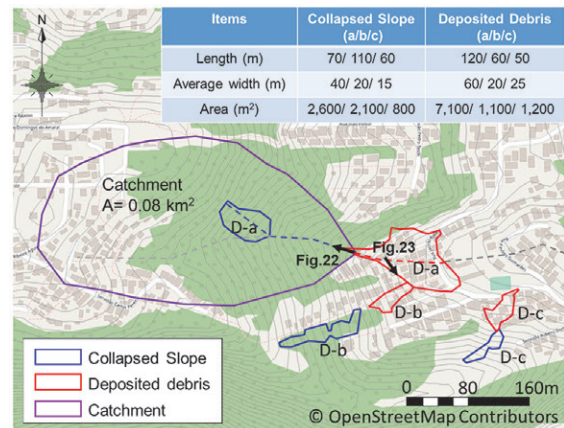
Three landslides, namely D-a, D-b, and D-c occurred at this Site D in Vira Felipe Neighborhood. The coordinates of each landslide are lat 22° 32' 4.15"S. long 43° 10' 51.75"W., lat 22° 32' 8.88"S. long 43° 10' 48.80"W. and lat 22° 32' 9.60"S. long 43° 10' 40.56"W. respectively. Information on these landslides is shown in **Fig. 21**. Of these, the investigation results of the catchment which includes the landslide D-a, where the debris flow likely occurred, are described below.

Fig.21 Topography and information of the landslides at Site D in Vira Felipe Neighborhood.

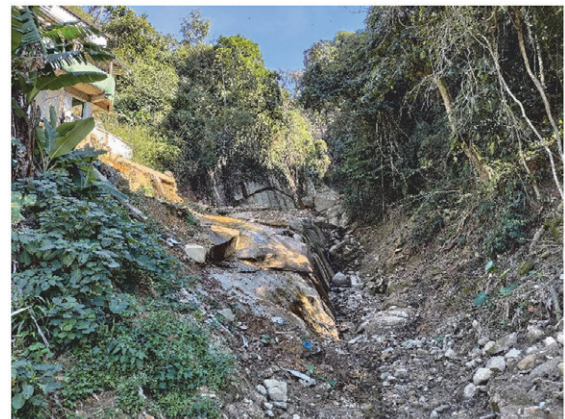
The landslide D-a occurred on the left bank slope of the midstream of a drainage basin with a catchment area of 0.08 km². The sediment from the landslide flowed down the stream and eroded the streambed to expose fresh base rocks (**Fig. 22**). The sediment also destroyed several houses on the mountain side of Jacinto Rabello Street at the valley outlet. The sediment that flowed down the stream contained boulders and deposited as it fanned out from the valley outlet (**Fig. 23**).

Fig.22 Streambed eroded by debris from the landslide D-a.

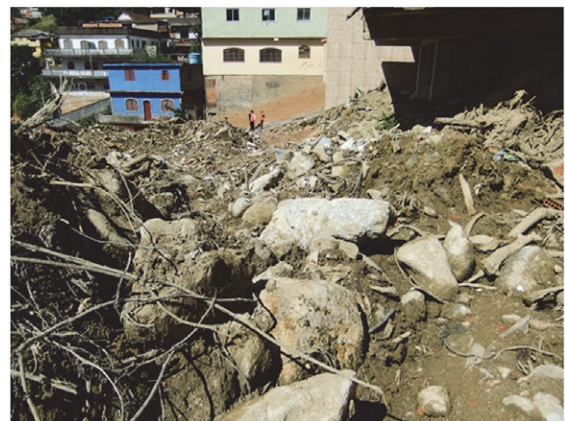
Fig.23 Situation of debris containing boulders of 1 m diameter or less deposited downstream from the valley outlet.

downstream of the valley outlet because most of the deposited debris had been artificially removed. However, the field conditions described above suggest that a landslide-induced debris flow likely occurred at this site. The reasons why the debris flow was stopped at the point around the 10-degree slope may be that the duration of the heavy rain was only about three hours causing relatively small amount of runoff, there were many boulders in the deposited debris, and houses crowded at the valley outlet acted as obstacles.

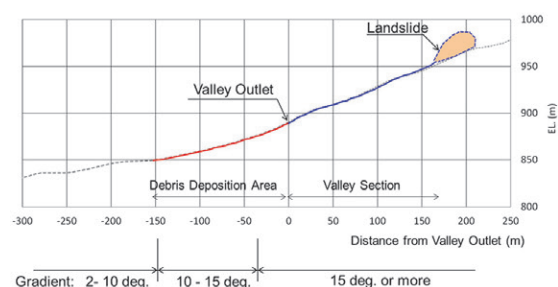
The longitudinal profile of the landslide D-a and its downstream section is shown in **Fig. 24**. The catchment of 0.08 km² in area, streambed in the valley

section with a gradient of 15 degrees or more, sediment deposition area from the valley outlet with a gradient of 10 to 15 degrees downstream from the valley outlet meet the conditions for the occurrence of debris flows. As of the first week of May 2022, when the field investigation was conducted, it was not possible to observe the debris accumulation structure

Fig.24 Longitudinal profile of the landslide D-a and its downstream section.
