LARGE MODEL TESTS ON THE BENTONITE MIXED SOIL LAYER UNDERGOING LOCAL SETTLEMENT (Part 2)

In Japan, bentonite mixed soil (BMS) which is made by mixing the bentonite into sand about 10 to 15 % in dry mass in order to have a hydraulic conductivity of less than 10 nm/s is widely used as soil barrier layer of landfill. The BMS layer may experience local settlement of the base ground. In case of large local settlement, the BMS could crack to lose the integrity of the barrier system. The authors constructed six large models of BMS layer in the field which had a thickness of 0.5 m, a width of 1.5 m and a length of 3.0 m. Among them, four models were underlaid with a geonet having a mesh size of 10 mm and different tensile strength. As results it is found that the crack appeared on the bottom surface of the BMS layer at the edge of the cavity and progressed upward at an angle of about 60 degree to the horizon. The models underlaid with geonet had also cracked but did not progress to the top surface while those without geonet had a crack reaching the top surface. It is also found that at the site where the width of crack appeared on the top surface was less than 2 mm an inflow quantity beca

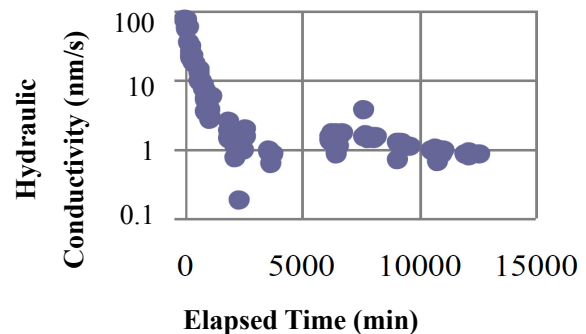
Figure 1 shows a variation in hydraulic conductivity obtained for the specimen with a compaction degree of 100 % using a flexible-wall permeability apparatus. The measured hydraulic conductivity indicates stable values of about 10 nm/s beyond an elapsed time of 40 hours, which satisfies the Japanese standard of less than 10 nm/s as clayey barrier system.

Figure 1 Variation of measured hydraulic conductivity

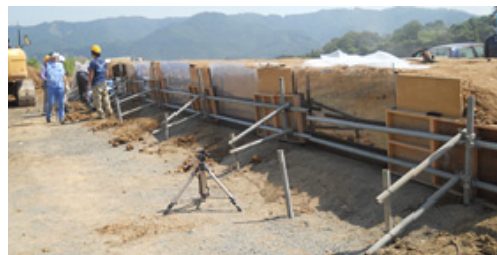
Figure 5 A view of constructed models of six BMS barrier system

were inserted into the side surface of the BMS barrier system in a 50 mm grid, as shown in Figure 4, for us to observe the deformation behavior easily. A transparent board made of Poly-carbonate with a thickness of 50mm was stood just in front of the side surface of the BMS barrier system. Figure 5 shows a view of constructed models of BMS barrier system in the field.

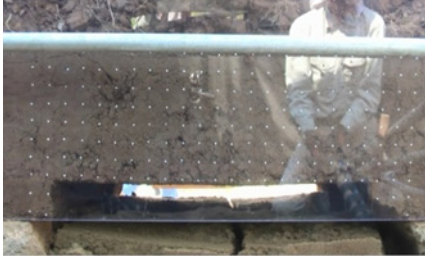
Figure 7 shows, as an example, the states of the BMS barrier system in case of tests on the model No-20, where no geonet was placed over a ditch of 0.2 m deep. When the sand was fully removed, the crack progressed up to 150 mm upward from the bottom and the first compacted BMS layer fallen down thoroughly.

Figure 7 State of No-20 on ditch width 1.20 m

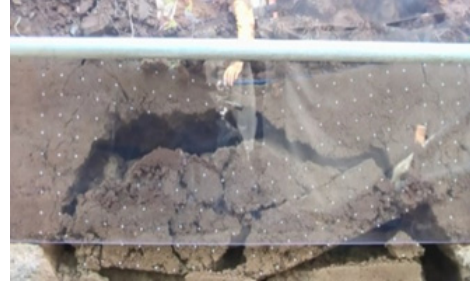
Figure 8 shows, as an example, the states of the BMS barrier system in case of tests on the model N248-20, where the BMS barrier system had geonet N248 and a ditch of 0.2 m deep.

When the sand was fully removed, the crack progressed up to 450 mm upward from the bottom and the first and second compacted BMS layer fallen down.

Figure 8 State of N248-20 on ditch width 1.20 m

In the case without GN, BMS layer occurred shear cracks at the bottom surface by local settlement. However, in cases of with GN, cracks and deformation occurred on the top surface of BMS layer by bending rather than shear failure.

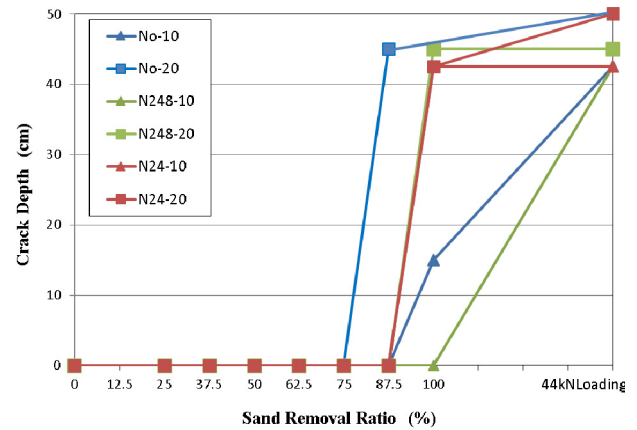
Figure 9 Progress of crack vs. Removal ratio of sand

Figure 9 shows a relationship between the removal ratio of sand and the progress of a crack from the bottom. It can be seen that as the ditch became deeper the crack appeared and progressed up to the top surface at lower removal ratio of sand. It is also found that the removal ratio of sand at of the crack appearing and progressing is larger in the model underlaid with a geonet than in the model without geonet.

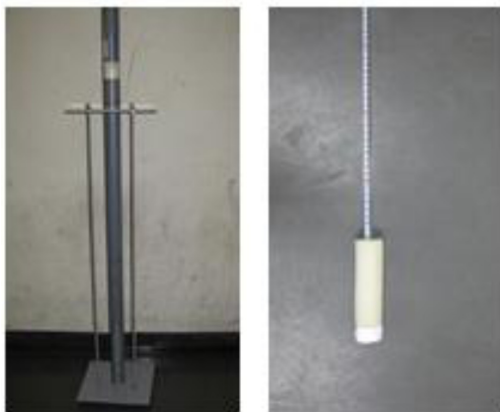
Two types of cylindrical pipe made of HDPE with an inner diameter of 0.7 m and 0.3 m, and height of 0.95 m were used as a water tank. To measure the variation of water level in the pipe, a water level indicator shown in Figure 10 was made, which consists of perforated pipe with a diameter of 40 mm and a pole pasted on the surface with a tape measure having a diameter of 6 mm. The tip of the pole had a float made of expanded polystyrene having a diameter of 30 mm and a length of 70 mm.

Figure 10 A water level indicator

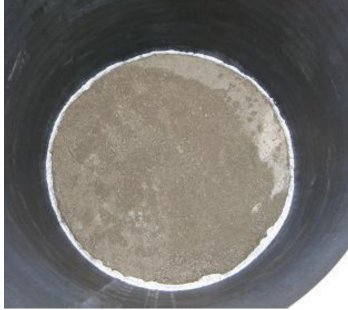
A cylindrical pipe made of HDPE was stood on the testing site. Its bottom tip was buried into the BMS barrier system by about 50 mm. The space between the inner wall of the pipe and the BMS was filled up with putty as shown in Figure 12. A vinyl sheet was spread on the inner side of the pipe and on the top surface of the BMS barrier system. Then the pipe was filled with

Figure 12 Putty filled between wall and BMS

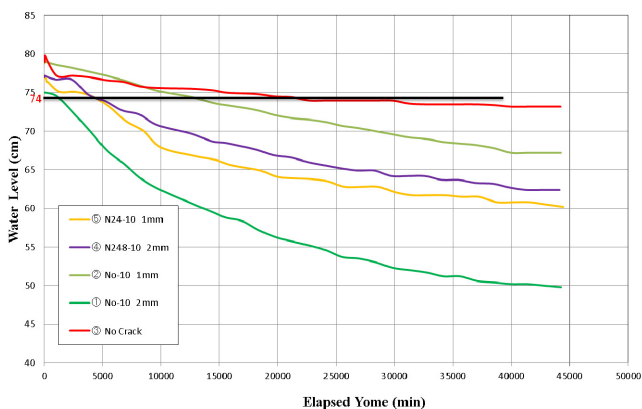
Figure 14 shows variations of the water level with an elapsed time on 700mm diameter tank tests.

Figure 14 Variation of water Level on ϕ 700mm test sites

Relating to Figure 14, it is thought that the gradient of the water level as an elapsed time, that is $\Delta h/\Delta t$, is proportional to the hydraulic coefficient of the BMS layer and water head. Therefor a ratio of the gradient in case of cracked site to one in case site 3 under same water level may suggest a ratio of the hydraulic conductivities, called as permeability ratio.

Table 2 shows the gradient $\Delta h/\Delta t$ under a water level of 74 cm. In the table, the permeability ratios are also listed. From the table, it is found that a permeability of BMS layer with cracks were several times higher than the complete section.

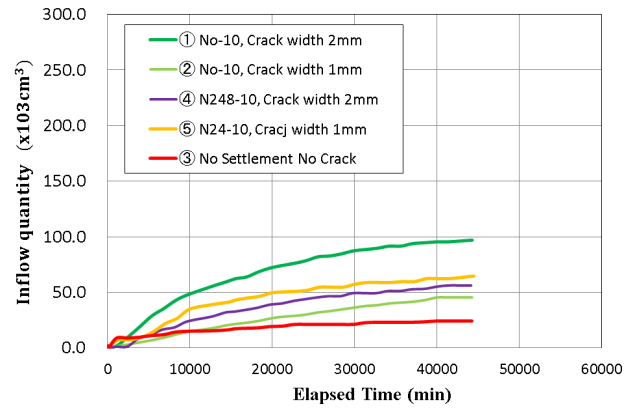
Figure 15 Variation of inflow quantity on ϕ 700mm test sites

Figure 15 shows a variation of the inflow quantity with an elapsed time on 700mm diameter tank tests, which was calculated by multiplying decrease in the water level by cross-sectional area of the pipe ($=0.385 \text{ m}^2$). In cases of site 1, site 2, site 4 and site 5, the inflow quantity shows almost stable beyond an elapsed time of about 44000 minutes ($= 30\text{days}$), though the inflow quantity at site 1 was largest and site 2 was the least. At these four sites, the width of the crack appeared on the top surface was less than 2 mm. At the all sites, it was also observed that the bentonite close to crack swelled to result in stopping the seepage through a crack.

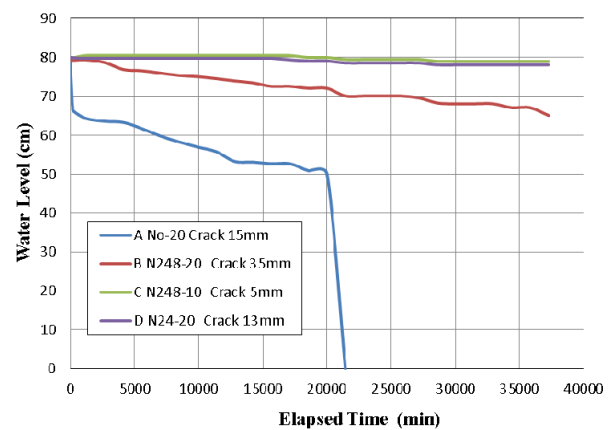
Figure 16 Variation of water Level on ϕ 300mm test sites

Figure 16 shows a variation of the water level with an elapsed time on 300mm diameter tank tests. In case of site A, the water level decreased rapidly until an elapsed time of 252 minutes. However, beyond an elapsed time of 252 minutes to until 20,000 minutes, the water level decreased gradually. And so, the water level decreased rapidly beyond an elapsed time of 20,000 minutes. This seems due to the fact that the water in the tank is frozen and melted.

From these facts, It is considered that as the crack did not pass through the BMS layer even if the width of the crack appeared on the top surface was as large as 5 mm, the permeation might stop by the swelling of the bentonite.
