Hydrological Observation of Subsurface flow spouting from Pipe Exits in Torrent Bed Material and its Triggering Rainfall Condition of the Nishinokaito River in Mount Fujiwara, Mie Prefecture, Japan

Takashi YAMADA¹, Hirofumi SATO² and Shingo YAMADA³
Hideaki KIKUCHI⁴

Key words: torrent bed material, subsurface flow spouting, hydrological observation, radial basis function network

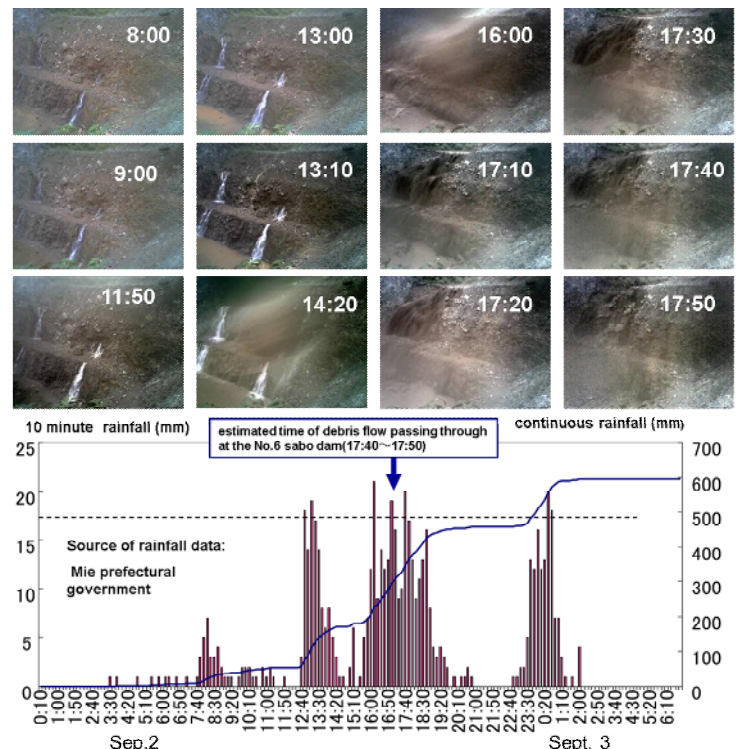
Fig.1 Subsurface flows with sediment spouting from cross section of torrent river bed material just before debris flow generation (taken on September 2, 2008)

[Yamada *et al.*, 2009] (Fig.1). From these facts it is known that when the subsurface flows spouted, pipe flows occurred within the torrent bed material. Therefore, these hydrological phenomena are considered to be important for the study on the generation process of the torrent bed scouring - induced debris flow at Nishinokaito River.

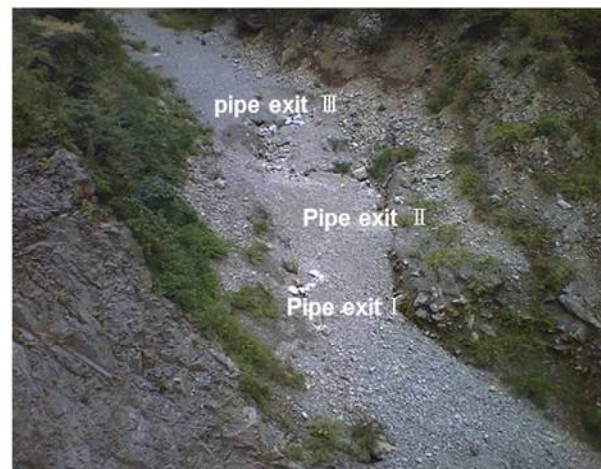
Fig.3 Exposed pipe exits(I ~ III) at the torrent bed material due to its scouring on October 24, 2008

mm), exposing the torrent bed material cross-section and allowing the confirmation of three pipe exits ("Pipe exit I", "pipe exit II" and "pipe exit III" from downstream) (Fig.3). In 2009, the positions of the exits of these pipes were measured and the areas surrounding the pipe exits, as well as their internal structure were observed using a borehole camera (Mini Sea Snake (KDM200SLM), diameter of camera head: ϕ 35 mm). Using pipe exit I, the one furthest downstream, as a baseline, pipe exit II and pipe exit III showed the ratio of +2.2 m and +4.9 m,

respectively. The slope distance between pipe exit I and pipe exit II was approximately 8 m, and that of between pipe exit I and pipe exit III was approximately 15 m. It could be confirmed from the photos that the depths of pipe exits I and III were approximately 1 m from the surface of torrent bed material while pipe exit II was approximately 1.3 m. According to the results of the boring investigation⁷⁾ at approximately 60m upstream from the locations where the above-mentioned pipe exits were exposed, the deposit depth of torrent bed material was approximately 9.6 m (the layer under it was a bed rock of limestone). There were mainly sub-angular breccias of ϕ 2-3 mm and coarse and medium coarse sands, partly mixed with cohesive soil from the surface to the depth of 3 m, under which there was a layer of approximately 1 m of sandstones mixed with cobbles. Although the deposit stratigraphy in the neighborhood of the above-mentioned pipe exits has not been investigated, the deposit stratigraphy where pipe exits existed can be considered to be mainly composed of sand gravels by the results of the boring investigation conducted at the immediate upstream area and from the observation of the cross section of deposits in the areas surrounding the surface exposed by the collapse of the torrent bed material.

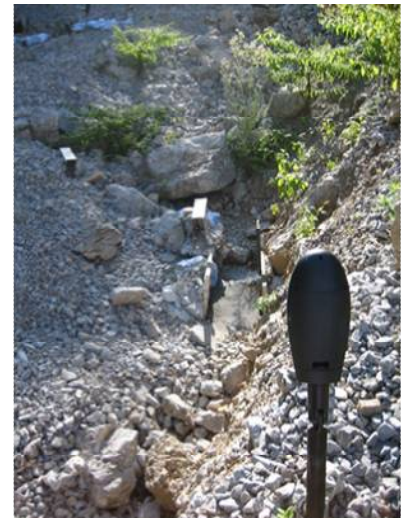
Fig.4 Flume and interval camera installed in the lower of pipe II exit at the torrent bed material

In order to clarify the hydrograph of subsurface flows from these pipe exits, a stainless flume (width: 10 cm, height: 30 cm and length: 40 cm) was placed in the vicinity of each pipe exit in July 2010. From the observations using an interval camera, so far, granules and fine sands often spouted from the pipe exits together with the subsurface flows. Therefore, in order for the flow in a flume to flow in natural condition as much as possible, fast-dry instant cement (as rough as fine sand) was spread on the bottom plate of the flume. The gradients of the flumes placed in the areas surrounding pipe I, II and III were 12.1 degrees, 15 degrees and 12.9 degrees, respectively (the relationship between water level and discharge had been previously clarified by a hydraulic model test). In order to take the photos of water levels at the exits of flumes, an interval cameras (KADEC21-EYE II and Brinno Garden WatchCam) was set at approximately 2-3 m downstream of each flume (Fig.4). The serial shoot duration of these cameras is 10 minutes. In addition, two interval cameras (KADEC21-EYEII, Brinno Garden WatchCam) were placed at the wing crown of the No. 6 sabo dam to take the wide area photos of the conditions of subsurface flows sprouting from these pipe exits during heavy rainfall (the serial shoot

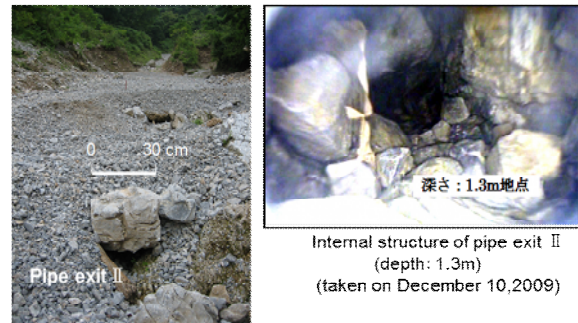
Fig.6 Exposed pipe exit II at the torrent bed material due to its scouring on October 24, 2008 and its internal structure

Fig.6 shows the area surrounding pipe exit II as well as the deepest internal area that could be observed (measurable depth of the inside of pipe by borehole camera: 1.3 m). Either pipe exit I or II or III presented the structure that gravels of several decimeters in diameter with each other and supported the walls of pipe exits, and that sands and gravels of a few cm in diameter surrounded it. The internal diameters of pipe exits I, II and III were several decimeters. When the inside of the pipe exits were observed by a borehole camera, neither flowing water nor stagnant water was recognized in any pipe exit at the time of observation (Dec. 12, 2009). The inside of all pipe exits showed a cylindrical shape and it looked as though it was continuing upstream. The gradient of the bottom surface of the inside of the pipe exit measured only from the section the camera head could be inserted into was approximately 7 degrees in each pipe exit. It was revealed that, the inside of each pipe exit showed the condition that the nearly circular gravels of 10 cm-several decimeters in diameter with each other and that there were the gravels of several cm in diameter and fine article components, such as sand and granules, mixed with silt at the bottom surface of the pipe exits. By the analysis of photos obtained by the observations conducted on and after Sept. 2, 2009, it was revealed that the more the subsurface flow spouting from the cross-section of torrent bed material increased, the more the turbidity increased [Yamada *et al.*, 2009]. This is considered to be caused by the sediment mixed with silt at the bottom surface of the pipe outflow when the subsurface water concentrate into a pipe and its discharge becomes large.

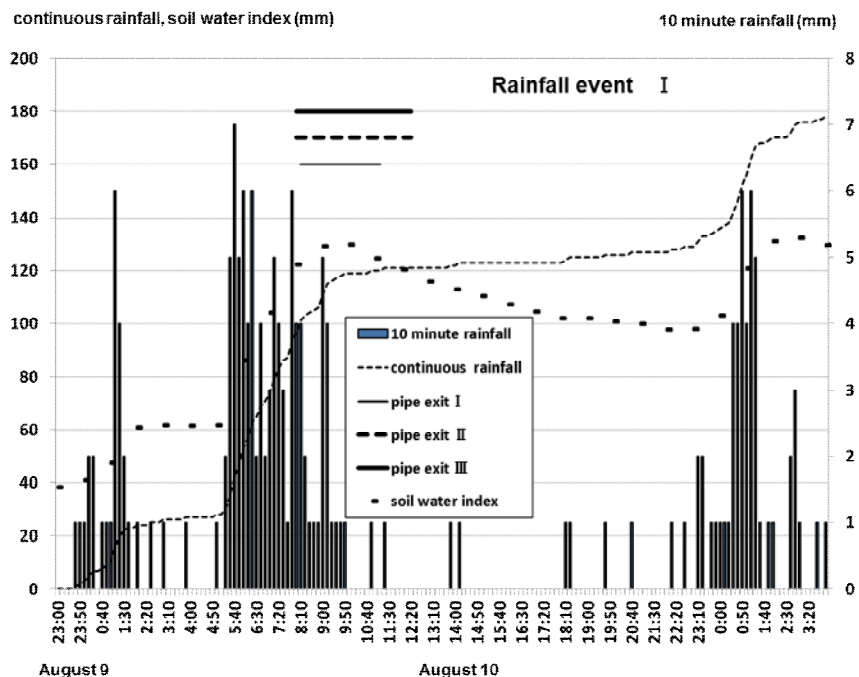
Fig.8 Actual situation of subsurface flow spouting from pipe exits of torrent bed material on August 9, 2010

Fig.8 shows the soil water index, continuous rainfall, amount of rainfall for ten minutes, times of generation and settling and spouting duration at each pipe exit during rainfall event I. Fig.9 shows the rainfall in Aug. 12, 2010 (hereinafter referred to as “rainfall event II”) and Fig.10 shows the case of rainfall in May 29, 2011 (hereinafter referred to as “rainfall event III”).

The continuous rainfalls when the subsurface flow spouted from pipe exits at the rainfall events I, II and III were 97-101 mm, 66-67 mm and 126-160 mm, respectively, and the soil water indexes (structure of tank model, values of each parameter and calculation method were the same as

those previously reported by the Mie prefectural government) were 122.5 mm, 125.4 mm and 109-130 mm, respectively. Although the values of the continuous rainfall until subsurface flow began to spout from pipe exits at the rainfall events I, II and III varied, it is characteristic that subsurface flow spouting is generated at a soil water index about 110 mm-125 mm.

The duration time of the subsurface flow spouting from pipe exit I at the rainfall event I was 3 hours. The subsurface flow spouting from both pipe exits II and III were 4 hours and 20 minutes; longer than the case of pipe exit I. During rainfall event II, the duration time of subsurface flow spouting from pipe exit I was 2 hours and 30 minutes and those from pipe exits II and III were 5 hours 18 minutes and 1 hour and 57 minutes, respectively. During rainfall event III, the duration time of subsurface flow spouting from pipe exit I was 3 hours, and those from pipe exits II and III were both 4 hours 10 minutes; longer than that from pipe exit I.

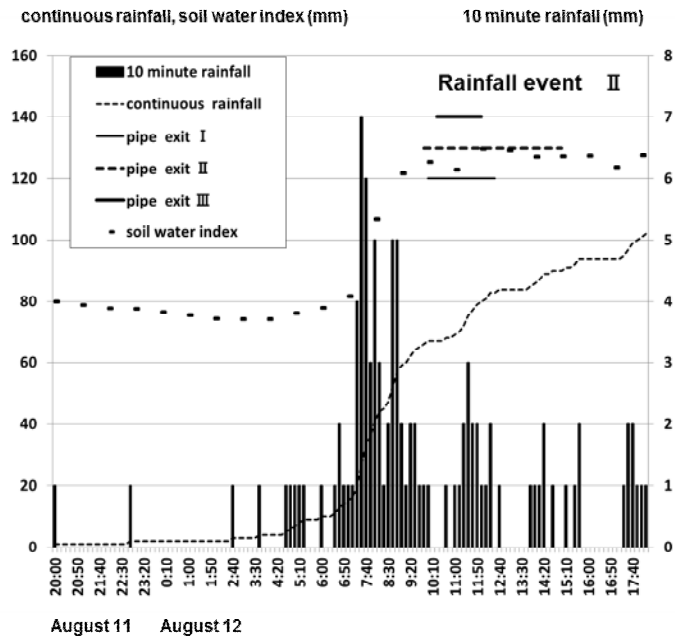
Fig. 9 Actual situation of subsurface flow spouting from pipe exits of torrent bed material on August 12, 2010

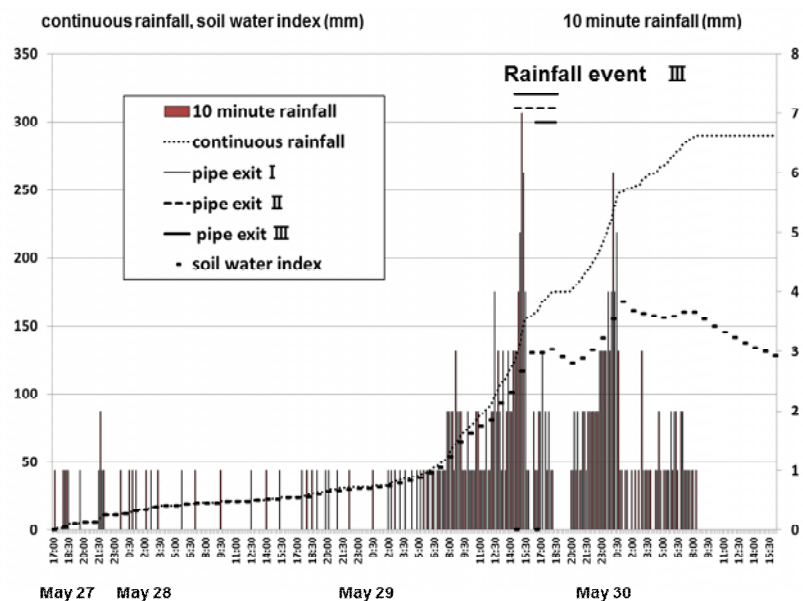
Fig. 10 Actual situation of subsurface flow spouting from pipe exits of torrent bed material on May 29, 2011

before the spouting from pipe exits, it was intermittently relatively heavily raining; 5-7 mm in 10 minutes. At the rainfall event III, immediately before the spouting from pipe exits, it continued to rain 1-3 mm in 10 minutes, after which it rained 5-7 mm in 10 minutes; equivalent to the approximate peak value in 10 minutes.

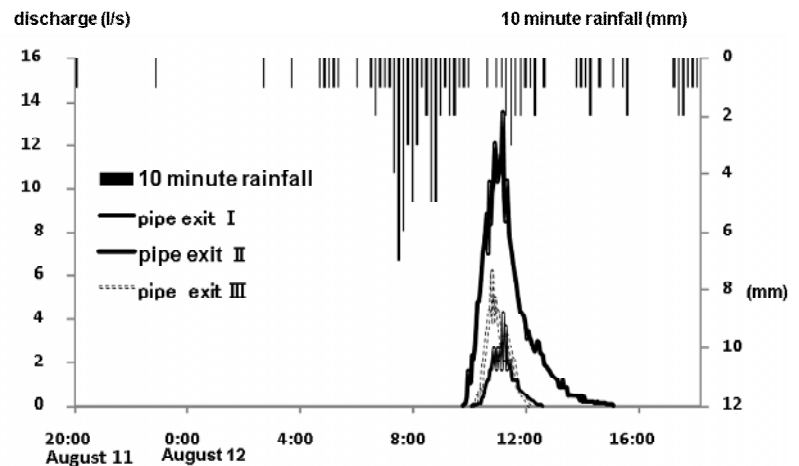
Fig.11 hydrograph of subsurface flow spouting from pipe exits of torrent bed material on August 12, 2010

Fig.11 shows the the rainfall event II, where a hydrograph of the subsurface flow from pipe exit was obtained (as for rainfall events I and III, there were some observation problems such as that sediment were deposited in the flume and the subsurface flow flow out of the flume). The hydrograph of each pipe exit shows a relatively sharp shape. The peak discharge and total discharge of the subsurface flow spouting from each pipe exit were largest in pipe exit II (the depth from soil surface was deeper than those of other two pipe exits at 1.5 m level) and those of pipe exit III were a little larger than those of pipe exit I. The generation times of the peak discharge of subsurface flow spouting from pipe exits were 11:11 for pipe exit I and II and 10:47 for pipe exit III.

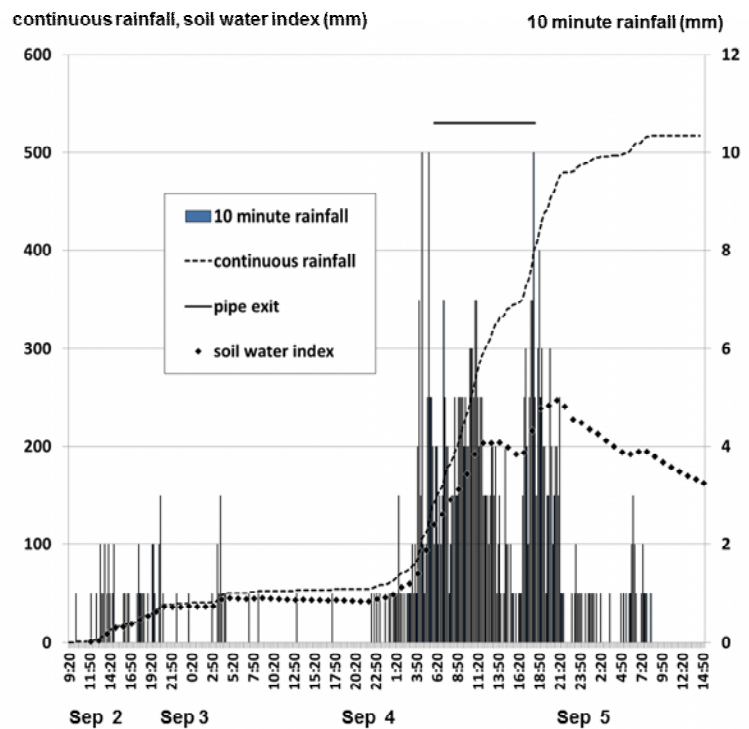
Fig.12 Actual situation of subsurface flow spouting from pipe exits of torrent bed material on September 4, 2011

Fig.12, Fig.13 show the generation times of subsurface flows spouting from pipe exits at time of rainfall (typhoon No. 12) of September 3-5, 2011. The subsurface flows spouting from pipe exits

generated immediately after the peak of 142 mm continuous rainfall, 120.7 mm soil water index and rainfall intensity for 10 minutes. Due to the interval cameras specification, photos after 18:00 on September 4 were not able to be obtained. Therefore, the situation of the subsurface flows spouting from pipe exits after the time cut off and settling are unknown. The subsurface flows from pipe exits were settled in accordance with the photo of 6:00 of Sept. 5.
