## Geo-Disaster Report

## Survey report on damage caused by 2019 Typhoon Hagibis in Marumori Town, Miyagi Prefecture, Japan

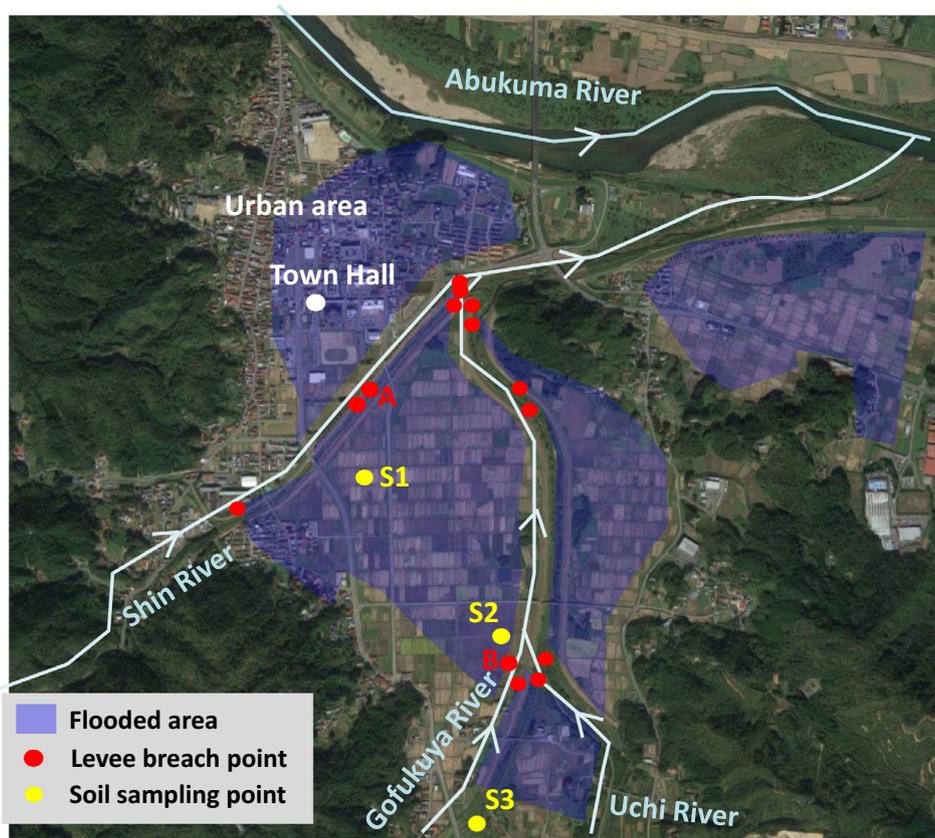
Fig. 6. Map of flooded area and levee breaches around urban area of Marumori Town.

orientations are viewed in the downstream direction. In addition, there were no traces of substantial overflow on the levees. It was concluded, therefore, that the inundation in the urban area was caused by inland flooding. On the other hand, there were many levee breaches on the right levee of the Shin River and the levees of the Gofukuya and Uchi Rivers. These levee breaches were caused by the rising water level of the rivers. As shown in Fig. 6, most levee breaches occurred near the river confluences. Soil sampling was performed (sampling points S1, S2, and S3 in Fig. 6) to investigate the sediment transported by the river flooding. A steel sampling tool, with a length of 1 m and a width of 0.1 m, was used for the sampling. Soil boring logs obtained at each sampling point are displayed in Fig. 7. As the samples were collected in active rice fields, the layers of cultivated soil indicate the surface layers before the river flooding. Silt and sand were transported by the river flooding; the river sediments covered the original surface with a thickness of approximately 40 cm. Ripple marks (Fig. 8) were observed on the ground surface at soil sampling point S3. This indicates that water, including a large amount of sediment, flowed over this area at a constant flow velocity.

Fig. 9 shows a photograph of a levee breach that occurred on the right levee of the Shin River. The location of the levee breach is point A in Fig. 6. Photographs (a) and (b) in Fig. 9 were taken from the right and left levees,

Fig. 10 displays aerial photos of the confluence of the Gofukuya and Uchi Rivers taken before and after the disaster. The aerial photos were obtained from Google Earth (Google). The location is shown as point B in Fig. 6. Levee breaches occurred at four points around the river confluence. The largest breach was observed on the left levee of the Gofukuya River. A large landslide ditch was also found near the levee breach (Fig. 11). Here, failure occurred in the normal direction, so this levee breach developed from the waterside to the landside. Our field survey team found driftwood remaining on top of other parts of the levee near the levee breach point. This indicates that overflow occurred around the levee breach point. In addition, although the team searched for traces of seepage failure in the levee, none were found around the levee breach point. It was therefore concluded that the levee breach had been induced by the erosion of the levee on the landside due to the overflow of river water.

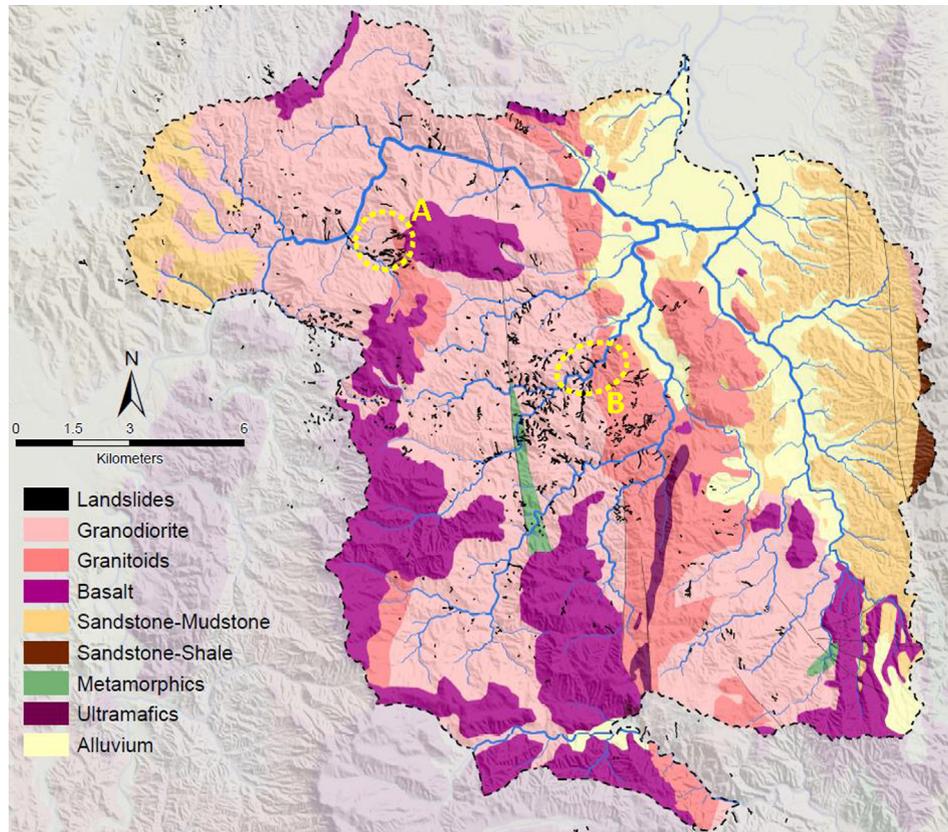
Fig. 12. Map showing distribution of surficial geology.

Fig. 12 presents a geologic map of Marumori Town overlain by the distribution of landslides that occurred during the 2019 Typhoon Hagibis. Information on the distribution of landslides, shown in black in the figure, was obtained from the website of the Geospatial Information Authority of Japan (GIAJ). GIAJ created this landslide distribution map using satellite image data obtained immediately after the disaster. It should be noted that landslides were not detected in part of the western area. The geologic map was made using data provided by the National

Institute of Advanced Industrial Science and Technology (AIST, xxxx, AIST, xxxx). The geology of this area has been reported in detail by Kubo and Yamamoto (1990). As shown in Fig. 12, many landslides occurred in Marumori Town. The landslides mainly happened in the north-western part and the middle reaches of the Shin, Gofukuya, and Uchi Rivers. Granitoids and granodiorite are widely distributed in these areas. Marumori Town is in the Abukuma Mountains. As granitoids and granodiorite are the main types of rock in the Abukuma Mountains, most parts of Marumori Town are underlain by these rocks. By comparing the distributions of landslides and rainfall (Fig. 3), a strong correlation can be found between them.

The locations of the Mawarikura and Koyasu communities are labeled at point A in Fig. 12. Fig. 13 presents aerial photos (downloaded from Google Earth) that were taken before and after the disaster. The flow paths of the debris flows occurring in this area are shown as yellow lines. One of the debris flows, shown in the photo given in Fig. 14, caused three deaths and one missing person (Fig. 13). A geologic map of this area is displayed in Fig. 15. This area consists of mostly mid-Cretaceous granitoids and granodiorites, with basalt in areas of higher ele-

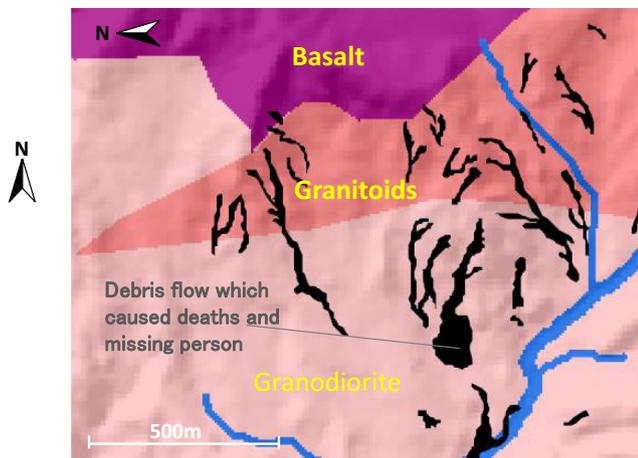
Fig. 15. Schematic geologic map of Mawarikura and Koyasu communities.

vations. When exposed to weathering, the surfaces of granitoids and granodiorite generally change to granite soil. Granite soil was observed in our team's field survey. Granite soil has been recognized as a special soil, and some researchers have reported its properties (e.g., Kazama et al., 2003; Matsuo and Nishida, 1968, 1970). It has been reported that granite soil easily loses strength and flows under high water content conditions. Thus, it is well known that granite soil is at high risk for forming landslides. In fact, granite soil landslides and their risks have often been reported in recent disasters (Hashimoto et al., 2020; Nishimura et al., 2020). Although the debris flow that caused casualties occurred in the granodiorite rock areas, other landslides occurred in the granitoid rock areas. Some of them happened near the boundary between the granitoids and the basalt. It is estimated that the ground water located near the boundary was one of the causes of the debris flow.

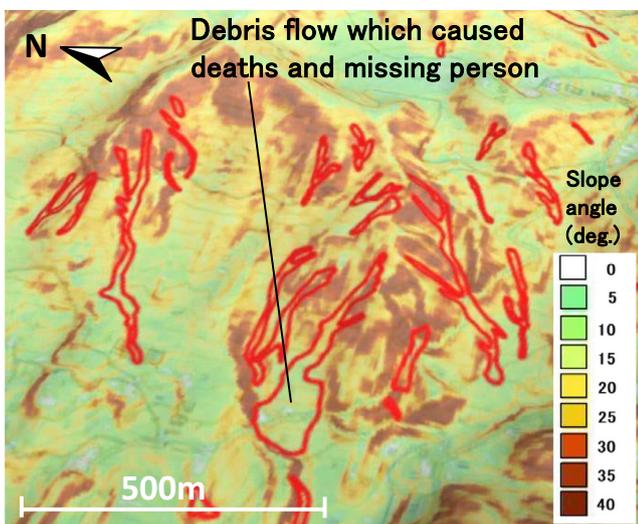
Fig. 16. Distribution of slope angles in Mawarikura and Koyasu communities.

The low slope angle of the flow path of the debris flows should be noted. Fig. 16 is a distribution map of slope angles in the area. The debris flow that caused the casualties had a slope angle of 30 degrees or more near its source, but most of the parts of the flow path had a slope angle of approximately 20 degrees or less. It would be difficult to predict that such a relatively low-angle slope would produce such a large-scale, far-traveling debris flow. Although the slope angle is mainly used to evaluate the risk of slope disasters, the underlying geology should also be carefully taken into account in risk assessments.

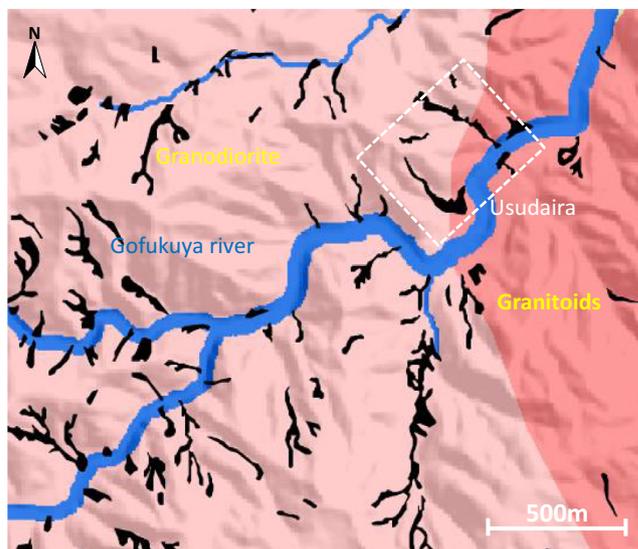
Fig. 19. Map showing distribution of landslides overlain on surficial geology in middle reaches of Gofukuya River.

A great deal of serious damage occurred in the middle reaches of the Gofukuya River area. Washouts of bridges and roads from river flooding (Figs. 17 and 18) were observed. Fig. 19 is a geologic map of the middle reaches of the Gofukuya River area, overlain by a distribution map of landslides. Many landslides occurred on the slopes along the Gofukuya River. The middle basin of the Gofukuya River is a narrow valley, and the bedrock consists mainly of granite and granodiorite. This area is at high risk for landslides because of both its topography and geology. In addition, the cumulative rainfall in the middle reaches of the Gofukuya River was particularly large (Figs. 3 and 5). In other words, in the middle reaches of the Gofukuya River, landslides occurred abundantly because of topography, geology, and heavy rainfall.

The Usudaira community is located in the middle reaches of the Gofukuya River, as shown by the dotted white line in Fig. 19. Fig. 20 shows aerial photos taken before and after the disaster. It can be seen from the figure that houses were destroyed by landslides and that the width of the river expanded greatly in the flood stage. Figs. 21 and 22 show damage to houses caused by landslides and river flooding. As landslides and flooding occurred at the same time, there was serious damage in the Usudaira community. Part of the debris flow path was previously designated as a sediment disaster hazard area, called a “yellow zone”, but in this event, a debris flow flowed beyond the designated zone. However, there were no casualties in this area, which is amazing considering the level of damage. One of the reasons for this result is that great efforts were made by the local residents to ensure strong mutual assistance. By sharing information among the residents and evacuating before the disaster, lives were protected in this area.
