**Disaster Report**

# **The July 2020 Rainfall-Induced Sediment Disasters in Kumamoto Prefecture, Japan**

**Key words :** heavy rainfall, collapse, debris flow, sediment disaster, Kumamoto Prefecture

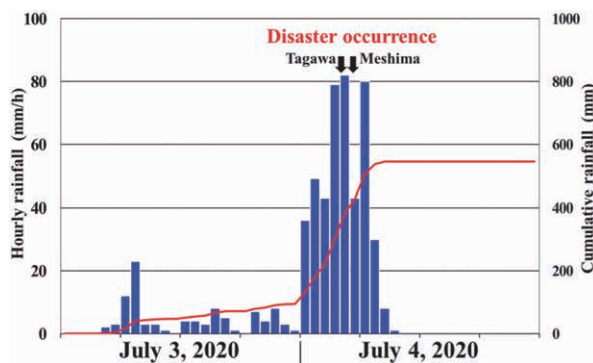
**Fig.4** Rainfall on July 3-4 (Ashikita observation station, Kumamoto Prefecture)

In Tagawa, Ashikita Town, a collapse occurred after 04:00 on July 4, killing three people (**Fig. 3**). According to rainfall data from near the disaster area (Ashikita observation station, Kumamoto Prefecture), 79 mm was recorded at 03:00-04:00 and 82 mm at 04:00-05:00 on July 4. Total rainfall from 04:00 on July 3, when the rainfall event began, to 05:00 on July 4, was 384 mm (**Fig. 4**).

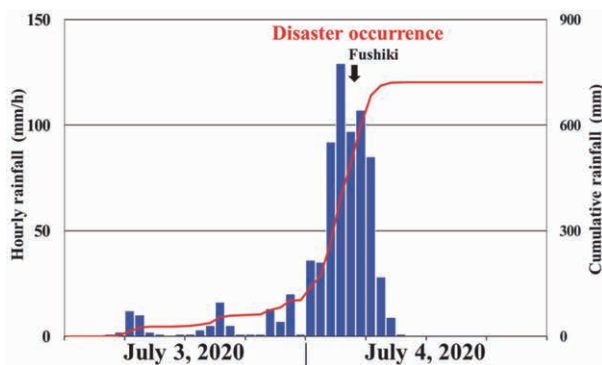
**Fig.12** Rainfall on July 3-4 (Tanoura observation station, Kumamoto Prefecture)

In Fushiki, Ashikita Town, a collapse occurred at approximately 05:00 on July 4, killing one person (**Fig. 11**). According to the rainfall data from near the disaster area (Tanoura observation station, Kumamoto Prefecture), 129 mm was recorded at 03:00-04:00 and 97 mm at 04:00-05:00 on July 4. There was cumulative rainfall of 492 mm from 04:00 on July 3, when the rainfall events began, to 05:00 on July 4 (**Fig. 12**).

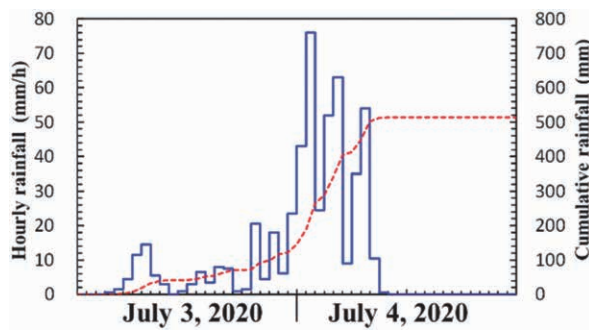
Fig.15 Rainfall on July 3-4 (Minamata observation station)

According to rainfall data from near the disaster area (Minamata observation station of Japan Meteorological Agency), hourly rainfall began to increase around midnight on July 4, with three peaks : 76 mm at 01 : 00-02 : 00, 63 mm at 04 : 00-05 : 00, and 54 mm at 07 : 00-08 : 00 on July 4 (**Fig. 15**). The

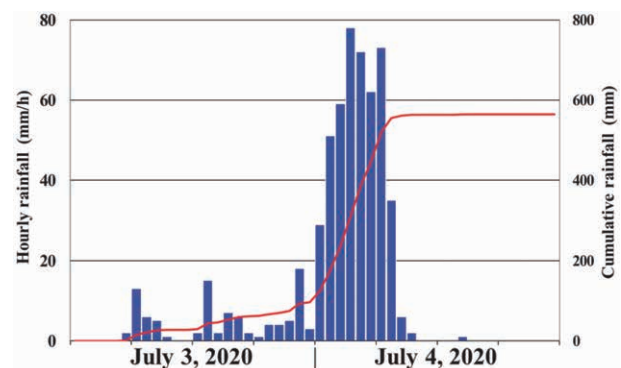
Fig.19 Rainfall on July 3-4 (Ministry of Land, Infrastructure, and Transport Kounose rainfall station)

A sediment and flood damage occurred in the downstream area in the Kawauchi River (Fig. 18). The residents evacuated beforehand and there were no human casualties; however, many houses were destroyed, and sediment was deposited on floors. According to rainfall data from the Kounose rainfall station installed by the Ministry of Land, Infrastructure, Transport, and Tourism, MLIT, a maximum hourly rainfall of 78 mm and cumulative rainfall of 564 mm were recorded on July 3-4 (Fig. 19).

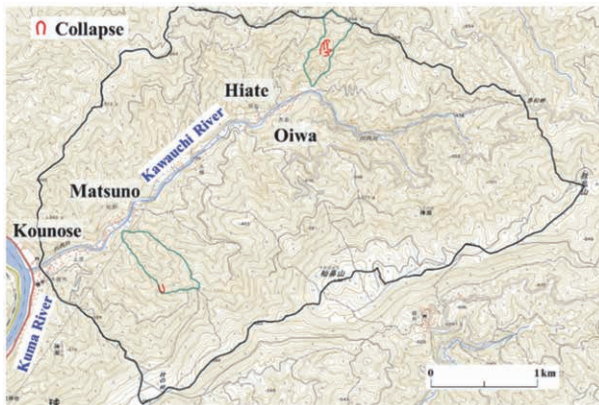
**Fig.20** Topography of the Kawauchi River basin (using a Geospatial Information Authority of Japan map)

The Kawauchi River has a basin area of approximately 11 km<sup>2</sup> and flows in a straight line in a northeast-southwest direction to the confluence of the Kuma River in the last 3 km section. Villages are scattered along this section (**Fig. 20**). The riverbed slope is 2° near the confluence with the Kuma River and 4° near the uppermost village. The geology of the basin consists of sandstone and shale, and fracture zones caused by faults are distributed in the basin.
