Disaster Report**Sediment-related Disasters in Petrópolis, Brazil, on February 15 and March 20, 2022***Hidetoshi OCHI¹, Yoshifumi SHIMODA², Yosuke NISHIO² and Rafael Pereira MACHADO³¹ Sabo Planning Division, Sabo Department, Ministry of Land, Infrastructure, Transport and Tourism (2-1-3 Kasumigaseki, Chiyoda-ku, Tokyo 100-8918, Japan) & JICA Expert

The municipality of Petrópolis was hit by heavy rains on February 15 and March 20, 2022 resulting sediment-related disasters. The disaster on February 15, 2022 was caused by heavy rain 253 mm which fell in 3 hours, resulting in 238 fatalities. The disaster on March 20, 2022 was caused by 548 mm/24hr of rainfall which lasted longer than that of February 15, 2022, resulting in seven fatalities. These heavy rains triggered more than 370 landslides, making it the worst disaster ever recorded in the municipality. This report provides an overview of the disaster and the characteristics of four of these more than 370 landslides as examples.

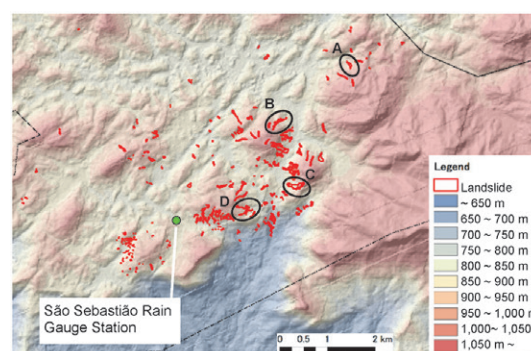
**Fig.2** Distribution of landslides and elevation classification in Petrópolis District created from ALOS World 3 D – 30 m. (Information on the landslide was added using city-created data. A-D in the figure are the locations of the sites shown in Fig. 10.)

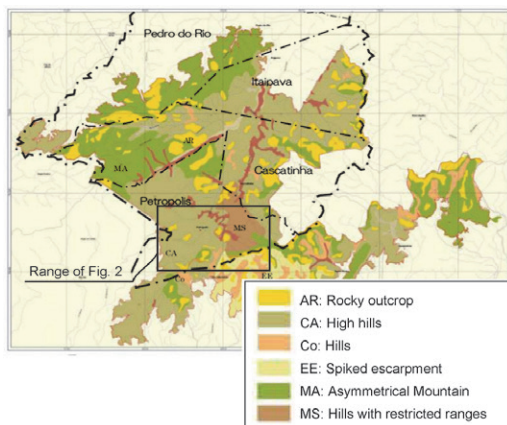
mountains by weathering and erosion, and rocky outcrops, with few flat areas (**Fig. 3**). In Petrópolis District where the series of disasters occurred, there are many hills and mountains with specific heights ranging from 50 to 200 meters above the valley floor. The landslides occurred on the slopes of these hills, rocky outcrops and mountains, striking residential areas on the slopes and lower part of slopes (**Fig. 4** and **Fig. 5**). Most of the landslides were shallow landslide with a narrow width relative to their length, originating around the knick point near the top of the slope. In the case of **Fig. 5**, shallow landslide occurred on the weathered surface layer of a granite outcrop at the top of the hill. From the air observation, most of the landslides were shallow landslide on the slopes, and there were very few cases that could be considered as debris flow.

Fig.3 Geomorphological map of Petrópolis. Administrative boundaries were added to the map of *Prefeitura Municipal de Petrópolis* (2016).

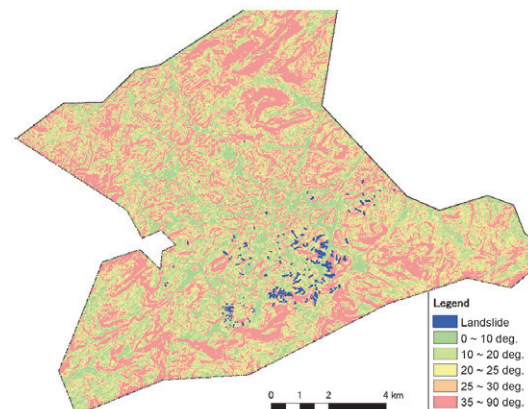
The slope classification map created from ALOS World 3D - 30 m (hereafter referred to as “AW3D30m”) combined with the distribution of landslides in Petrópolis District is shown in **Fig. 6**. Using satellite imagery, each landslide was divided into collapsed

Fig.6 Distribution of landslides and slope classification in Petrópolis District created from ALOS World 3 D - 30 m. (Information on the landslide was added using city-created data.)

slope and deposited debris. The average gradient of collapsed slope was 30.4 degrees (calculated from AW 3D30m), and the average collapsed slope area was 1,600 m².

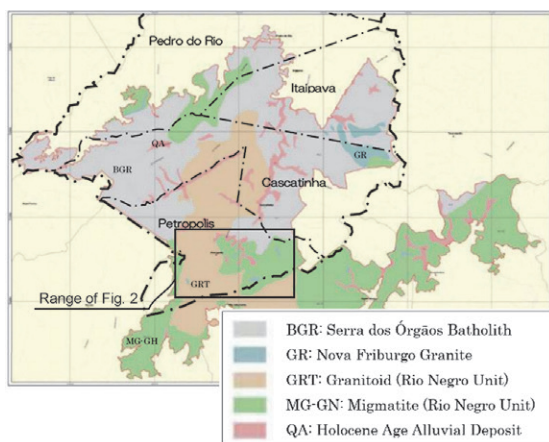
The municipality of Petrópolis is located on the Atlantic shield with Precambrian basement rocks [Kamitani, 1984] consisting of granitoid (Rio Negro Unit), migmatite (Rio Negro Unit), and Serra dos Órgãos batholith of granitic origin (Fig. 7). Field investigations revealed that the granite forming the hills and mountains had developed parallel cracks on the surface, where there was a risk of bedrock collapse. The weathered residual soil covering the granite was as thin as 1 ~ 2 meters and lateritized.

Fig.7 Geological map of Petrópolis. Administrative boundaries were added to the map of *Prefeitura Municipal de Petrópolis* (2016).

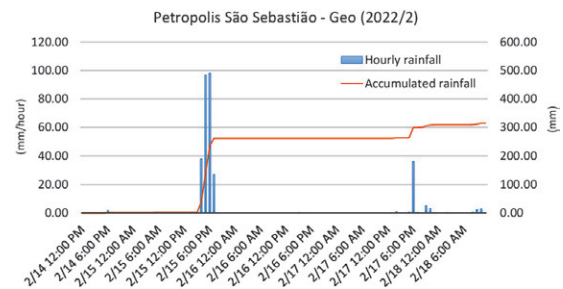
Figure 8 shows the hourly rainfall at São Sebastião rain gauge station from February 14 to 18, 2022. Rainfall was concentrated in a four-hour period from 15:00 to 19:00. The maximum hourly rainfall was 115.2 mm (from 16:30 to 17:30) and the maximum 2-hourly rainfall was 196.2 mm (from 16:30 to 18:00).

Fig.8 Hourly rainfall at São Sebastião rain gauge station for February 14~18, 2022 organized from CEMADEN observation data.

30). This maximum 2-hour rainfall of 196.2 mm was higher than the monthly average rainfall for February in Petrópolis (185 mm). Photos taken by a resident at 17:44 in Petrópolis District show the occurrence of a landslide, which suggests that the landslide occurred around the time when the peak of rainfall intensity was recorded.

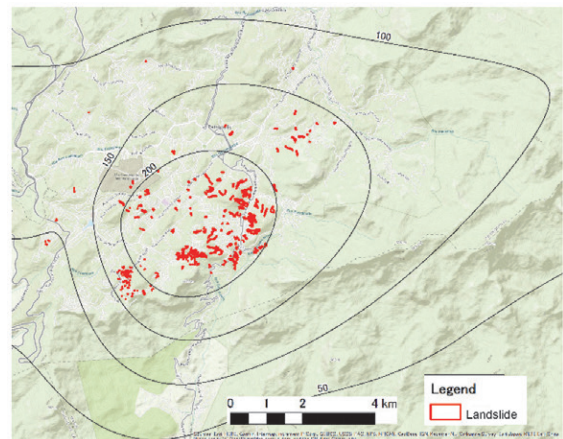
Fig.9 Isohyetal map of 3-hour rainfall on February 15, 2022 from 15:30 to 18:30 organized from CEMADEN observation data.

Figure 9 shows an isohyetal map of 3-hour rainfall from 15:30 to 18:30 on February 15, 2022, organized from CEMADEN's 14 rain gauge stations in the municipalities of Petrópolis and Magé. It shows that landslides were concentrated in the area where the 3-hour rainfall exceeded 200 mm/3h. In addition, most of the landslides were contained within the range where rainfall exceeded 150 mm/3h.

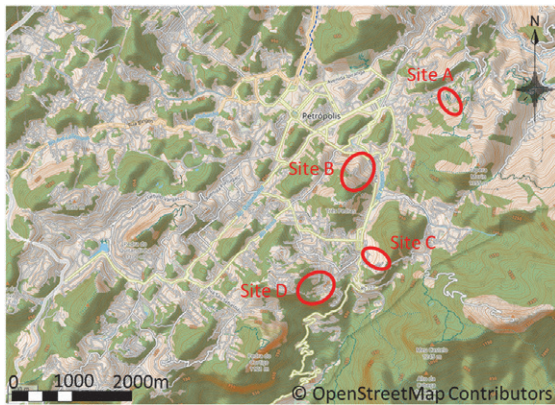
Among the landslides that occurred in Petrópolis District, we were able to visit and carry out investigation four sites (Fig. 10) where the scale of damages were relatively large. Name of the sites were designated as Sites A through D from north to south. Details of the mass movement and damages at each

Fig.10 Location map of Site A–D where field investigation was carried out.
